## REHABILITATION SOLUTIONS FOR EXISTING STRUCTURES IN ROMANIA

Sorin Dan<sup>1</sup>

**Summary:** *The paper deals with aspects regarding strengthening of reinforced concrete existing structures in seismic zones, like Romania. Some case study and the rehabilitation of characteristic structures are analysed. The rehabilitation solutions were chosen in accordance with the actual stage of building deterioration as well as function of the actions characteristics. Classic (reinforced concrete and/or steel) and modern (Carbon Fibre Reinforced Polymers) materials and technologies for strengthening have been used.*

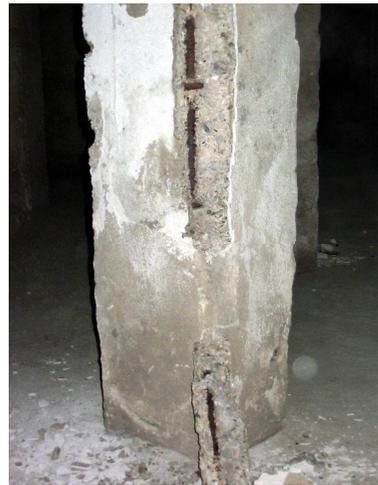
Figure 2. Reinforcement corrosion of discharge funnel supporting columns

The main damages are due to water infiltration and high humidity inside of each cell bottom part, which caused important dislocated concrete cover and corrosion of the columns steel reinforcement (Figure 2).

The strengthening of supporting columns for the discharge funnel consists of steel profiles (Figure 3). This solution has a smaller cost than CFRP materials. On the other hand, steel profiles have a better buckling behaviour than CFRP strips.

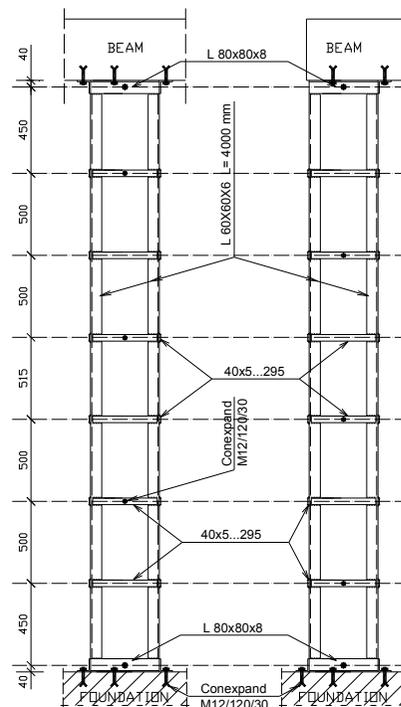
Figure 3. Strengthening solution with steel profiles

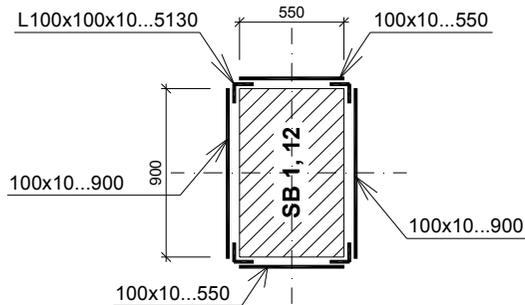
On examination of the building and from non-destructive measurements no important damages of the RC structure were noticed. Some local damage due to incipient reinforcement corrosion was detected at the columns of the ground storey.

Figure 6. Strengthening solution with steel profiles

Rehabilitation solution consists in strengthening of the columns located at the ground storey (*Figure 6 and 7*): some columns were strengthened in 1999 to prevent the local damages due to reinforcement corrosion; the other columns were rehabilitated in 2004

for decreasing the lateral displacements (drift limitation conditions) and for a homogeneous columns stiffness at the ground storey.

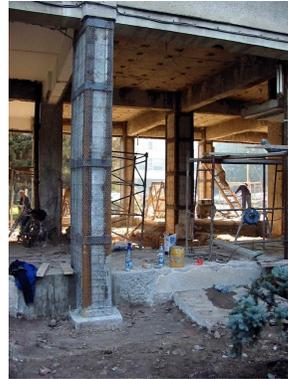
Figure 7. Rehabilitation solution of columns

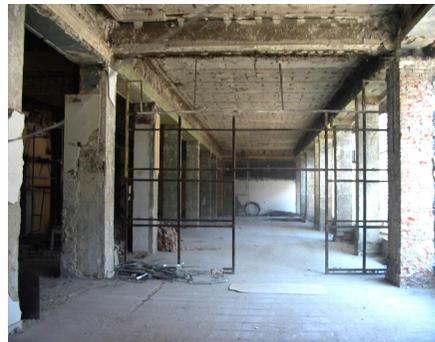
Figure 9. Longitudinal reinforced concrete frames

Initially it was an entire masonry structure, but later the ground floor was changed: some resistance brick walls were cut and two longitudinal RC frames were erected to sustain all the vertical loads. Due to this architectural operation the structure became more vulnerable at seismic actions: by the transversal direction main part of the ground floor became unstable at horizontal actions because of some erected columns with hinge

connection at both ends (masonry wall supports from the underground floor and ground storey). Other vulnerabilities of the building consist of: overall lateral stiffness values along the two main axes are different; lack of seismic joints to divide building parts having different dynamic characteristics; lack of straps at each floor.

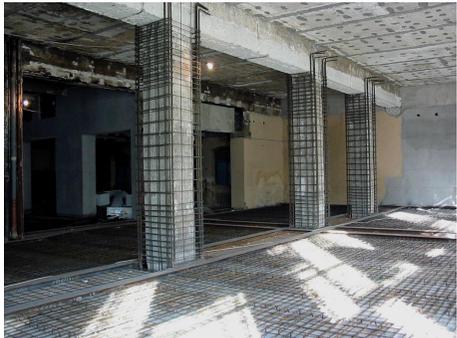
*Figure 10. Strengthening of columns*

- strengthening of half from the existing columns (60x60cm coated by RC to become 90x90cm – *Figure 10*) and erecting of new transversal RC beams in order to create new transversal frames (*Figure 11*);
  - strengthening by RC coating of existing longitudinal beams;
  - rehabilitation of some structural elements having corroded reinforcement.

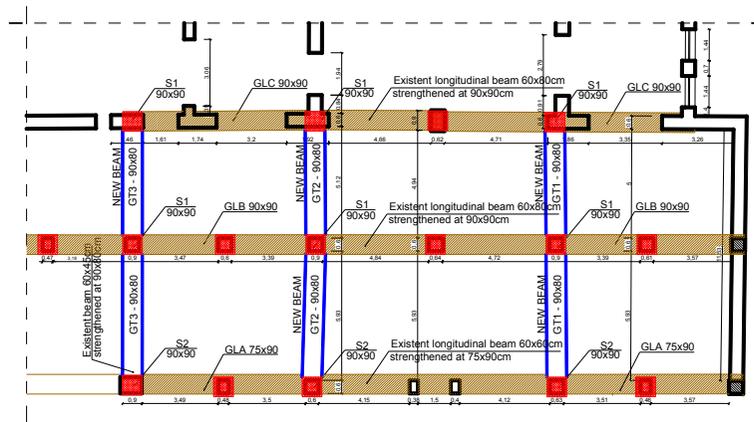
Figure 11. Ground floor rehabilitation
