ASSESSMENT OF THE SITUATION AND REMEDIATION MEASURES OF CHILDREN INSTITUTION " DOLORES " IN BELGRADE

Summary: This paper presents the assessment of damaged building built on sloping ground on the basis of the position and orientation of cracks recorded . It is believed that the damage to the building occurred as a result of landslides activation.

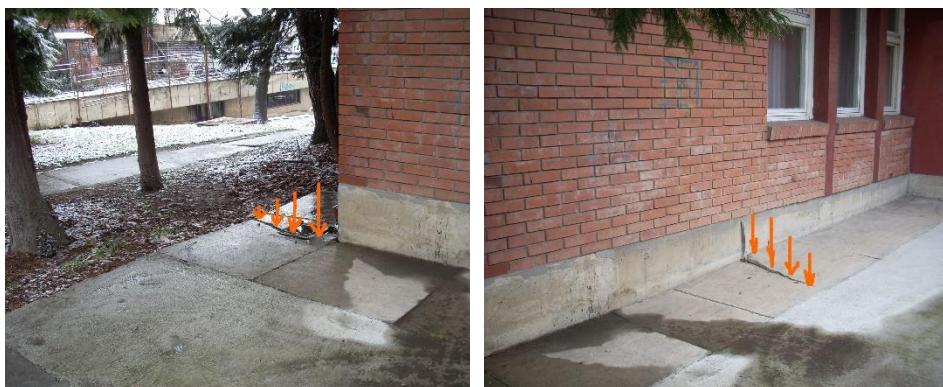
Figure 1. Cracks at the top of the slope

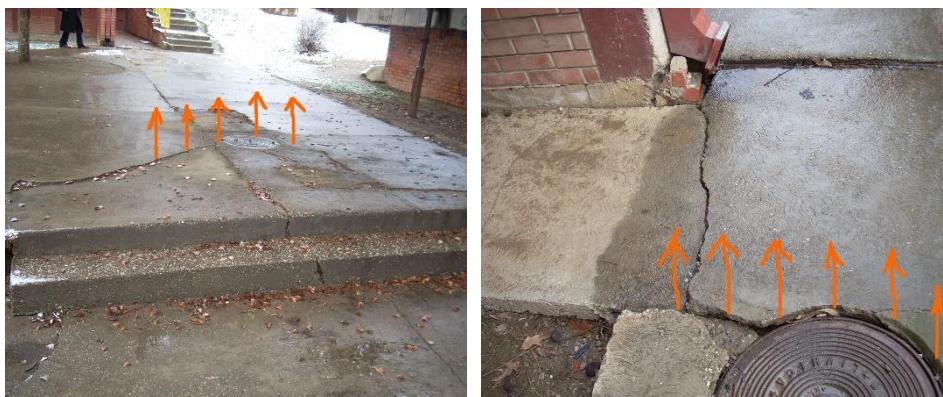
Figure 2. Cracks at the slope base

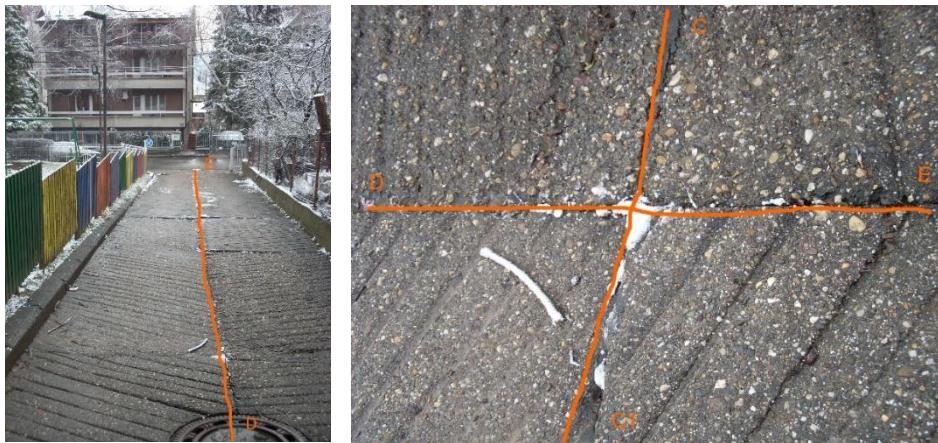
Figure 3. Rotation axes of sliding body – characteristic longitudinal cracks, shearing

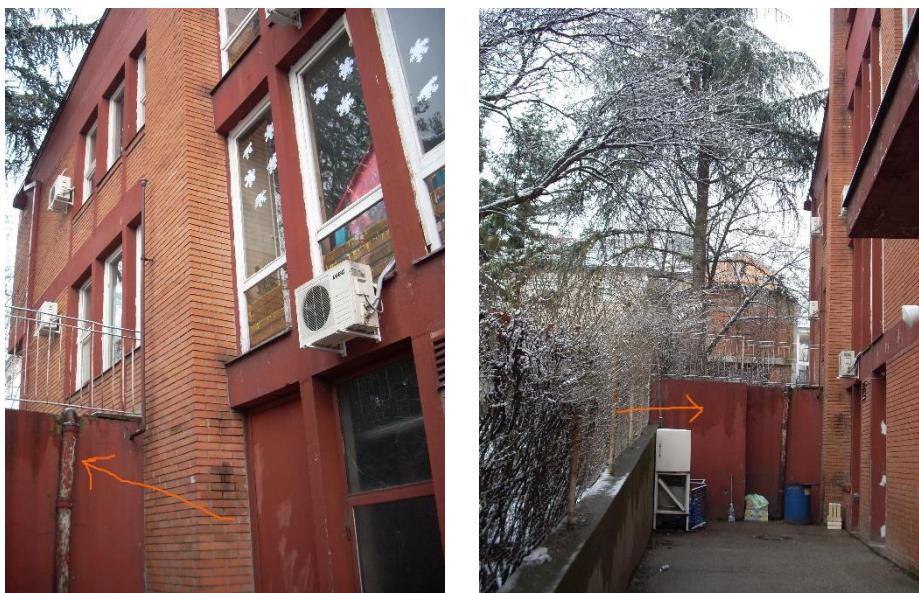
This is probably the case of the sliding body weight increasing due to the construction of the building on a natural slope (weight on the slope increased) , followed by the penetration and action of rainwater. On the retaining wall were not made barbicans (circular openings in the retaining wall) through which takes place the drainage of water

Figure 4. Retaining wall at economic entrance

which failed to be collected by rainwater sewers. Before the start of the repair works it is necessary to drill the retaining wall at the economic entrance at height of 0.5 m from the level of the entrance, with diameter Ø100 at a distance 1.20 m, and by prefabricated gutter lead to the level of street storm sewers.

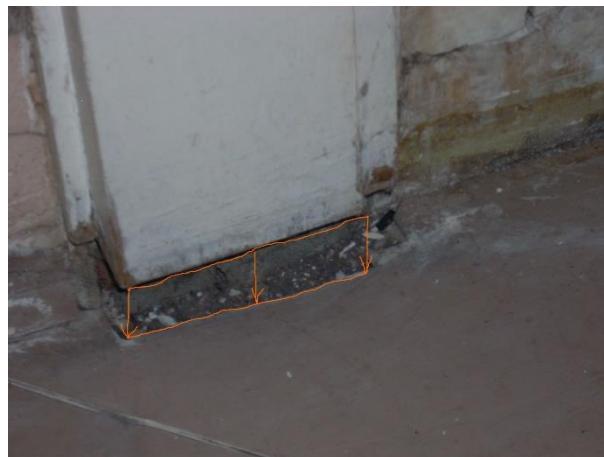
Figure 6. Ground slab in the ground floor between rooms 26 and 27

- Geodetic survey of the terrain
- Geological soil profile
- The level of groundwater
- Activity and classification of slope
- Research works for determining the dimensions and depth of the foundations have to make the main project of rehabilitation of ground slab and landslides.

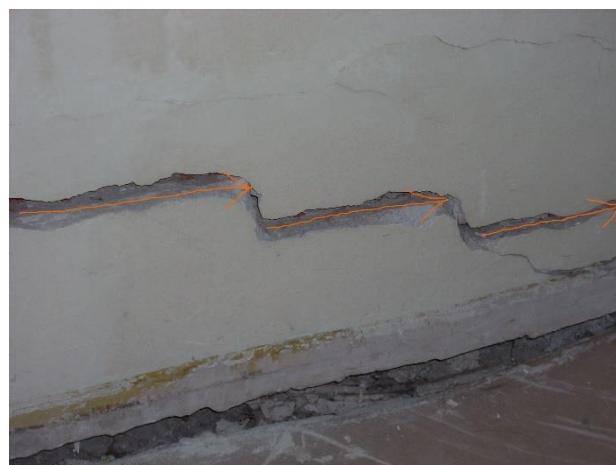
Figure 7. The cracks on the wall of the room 26 keep track of the terrain slope

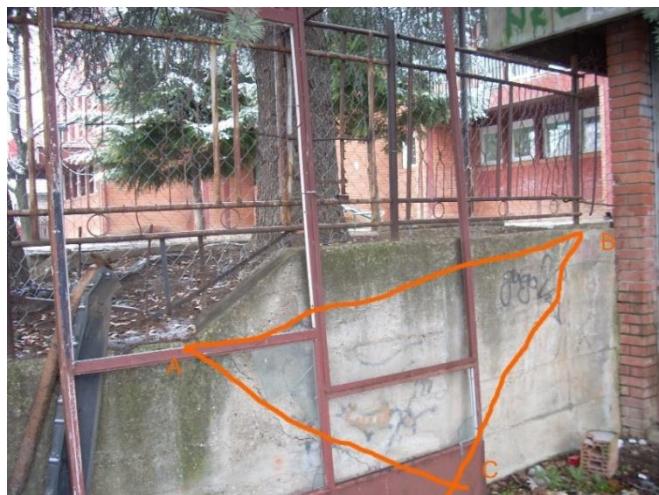
Figure 8. Condition of the retaining wall in 2008

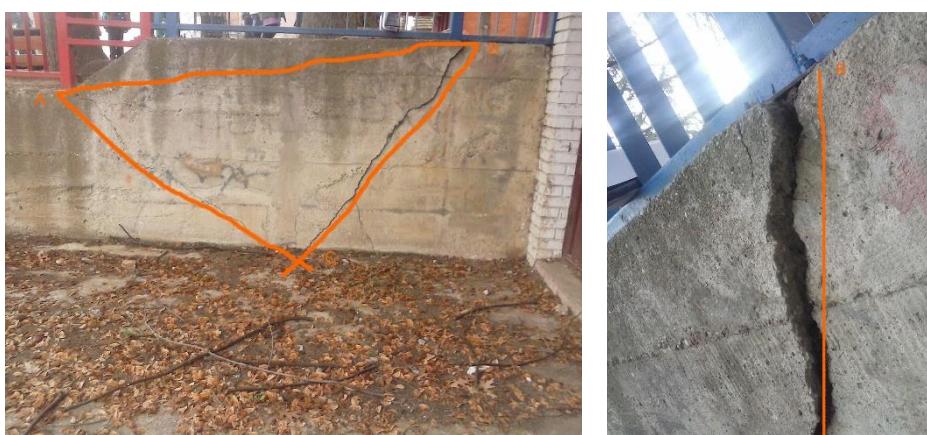
Figure 9. Condition of the retaining wall in 2016

Condition of retaining wall 2016. (Formed sliding plane – sliding along the axis CC 1 open cracks about 7 cm). Figure 10 shows that after the rehabilitation in December 2015, there is no cohesion in the direction CC1 $c = 0$.
