ASSESSMENT AND REPAIR OF RC WALL FOR DEFENSE AGAINST SAVA FLOOD WATERS

Summary: *At the end of the seventies, it was noted that built defensive line, along the left bank of the Sava River in the city core of Sremska Mitrovica (km 3+009 to 6+150), does not meet the criteria for defense against the ruling 1% of the great water of the river. Accordingly, the drafting of project documentation and, later, construction of the facility, started. Defense on section 4+189 to 4+232km represents the reinforced concrete wall. During the period of high water levels of the Sava River in May 2014, the water leaks through the concrete wall were registered. In this study, a series of activities to assess the condition of the RC wall and the proposal for its repair were carried out, in order to restore full functionality of the defensive wall, i.e. the defense of the city of Sremska Mitrovica from the flood waters of the river Sava.*

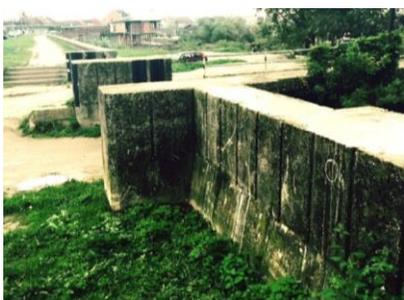
Fig. 1. The concrete wall on the left bank of the Sava River

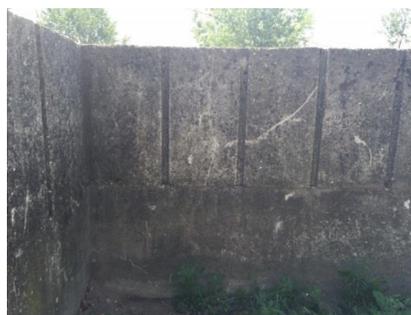
Fig. 2. The appearance of the "old" and "new" part of the concrete wall (downstream part)

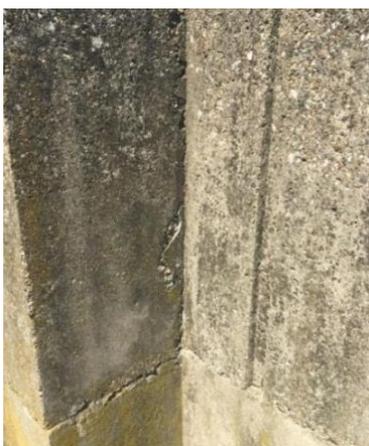
In the upstream part of the defensive wall, crack width of 1mm was registered (Figure 3). The crack is located at the place of the wall thickness change. Crack is vertical and passes through the new (upper) and the old (lower) part of the wall and covers the entire cross-section. The crack is wider on the new section of the wall.

In some places, local crushing of concrete in the zone of cracks has been observed. The figure clearly shows the erosion of the surface layer of concrete, which manifested with flushing of cement stone and bearing of larger aggregate grains. This appearance is characteristic for the so-called "new" part of the of the concrete wall.

Fig. 3. Vertical crack on the interior defensive side of the concrete wall (at the place of the extension of the wall)

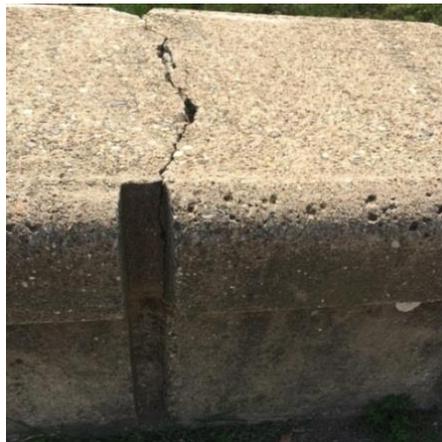
Characteristic damages of the upper part of the concrete wall are vertical cracks, passing throughout entire wall thickness. Described cracks are usually located in places of cannelures - Figure 4.

Fig. 4. Cracks in the concrete wall (view from the side and top)

Width of the cracks ranges from 0.5 - 5 mm, and pass through the cement stone (aggregate grains bypassed). On some cracks white spots were observed, as a result of leaching of cement stone. Possible causes of the described cracks are the shrinkage of concrete and/or thermal contraction. Besides the cracks, on the downstream part of the concrete wall, following damages were observed: erosion of the concrete surface in the form of increased porosity of the surface layer of concrete, flushing of cement stone due to bearing of coarse aggregate grains.

Cracks in the downstream part of the concrete wall (in the "new" - upper part) can be repaired by roating and sealing technique (Figure 11).

- Surface sealing of cracks on the sides of the concrete wall to prevent loss of resin.
- Roating of concrete in the crack zone on the upper side of the wall, in a "V" shape, to a depth of 2cm - formation of a "reservoir" on the upper side of the wall.
- Sealing the cracks by injection elastomeric material with low viscosity.
- When it is determined that the resin does not longer penetrate into the crack, floating resin on the top should be sprinkled with quartz sand.

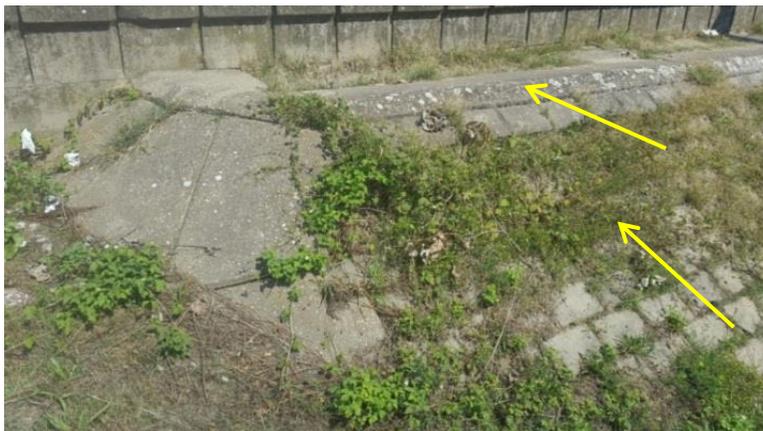
Visual inspection revealed settlement of certain parts of the concrete cover on the horizontal part of the embankment. It is assumed that the contact filtration, below the slipway of pontoon bridge, consequently caused a settlement of this cover, which is close to the opening for slipway of pontoon bridge (Figure 5).

Fig. 5. Settlement of concrete cover over a length of about 10 m

Settlement of concrete cover on the undefended side of the wall should be repaired by reconstruction of concrete cover and embankment part (Figure 12).

- Careful removal of concrete cover over a length of 10 m.
- Reconstruction of the front part of the concrete prisms (optional) with concrete (1.0 m³ of concrete needed for the repair of this part of the cover)
- Filling settled embankment part with approximately 10 m³ of sand and about 3 m³ of buffer layer of gravel.
- Replacing the concrete cubes.

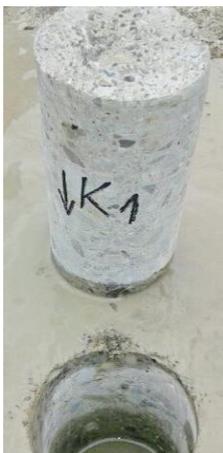
Figure 6 - The concrete core for determination of the concrete class

Based on the tests of compressive strength of concrete samples, reduced to the age of 28 days, it was found that the concrete incorporated in the concrete wall (new part) meets the requirements for class C35/45.

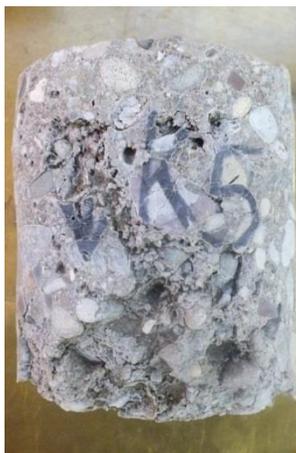
Figure 7 - The appearance of the damaged sample after 50 cycles of freezing and thawing

During the test, after 50 cycles of freezing and thawing, five samples suffered damages due to the destructive effects of frost, such as:

- net-like fissured in the concrete surface,
- crumbling, spalling and falling of concrete parts.

After that, testing was stopped and it was concluded that the concrete incorporated in concrete defensive wall on the embankment on the left bank of the Sava in Sremska Mitrovica does not meet the minimum class of resistance to frost - M50.

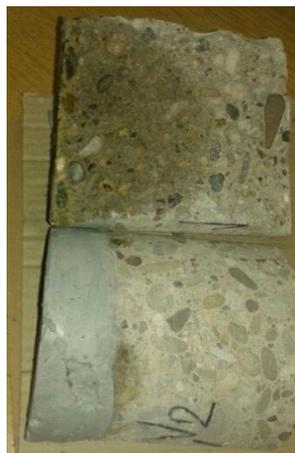
Figure 8 - Concrete specimen with visible border of penetrated water

Based on the maximum depth of penetration of water under pressure, it was concluded that the concrete incorporated in concrete defensive wall on the embankment on the left bank of the Sava in Sremska Mitrovica meets water-impermeability class V4, as the average depth of water penetration is 50 mm.

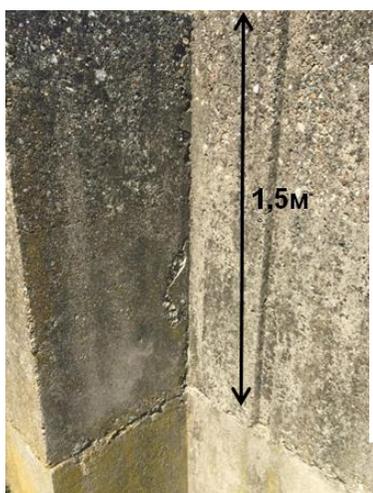
Figure 9 - The appearance and position of the subject crack

Vertical cracks on the upstream part of the concrete wall can be repaired using the technique of injection under pressure (Figures 9 and 10).

- Drilling of injection channels, alternatively from the left or right side of the crack at an angle of 45° , so the gap is cut in the middle of concrete wall.
- Surface caulk on the sides of the wall with quick-setting mortar to prevent the loss of resin.
- Setting the packers from stainless steel, with double protection, that endure the pressure up to 200 bar.
- Injection of cracks using the elastomeric resin and a one-component injection pump.
