EXAMPLES OF REHABILITATION OF RC BRIDGES OF SMALLER SPANS

Summary: *The paper presents conducted rehabilitations on two bridges over the Paklešnice River, as well as the rehabilitation of the bridge over the Kravaričkog Brook at the Forestry House in Gornji Lajkovac Municipality of Mionica. Prior to the conducting control structural analysis of bridges and testing the quality of installed materials: concrete and reinforcement, detailed recording of all necessary dimensions of existing bridges was performed. On the basis of the performed measurements and conducted structural analysis of the obtained results for the relevant influences, the necessary remediation measures have been carried out.*

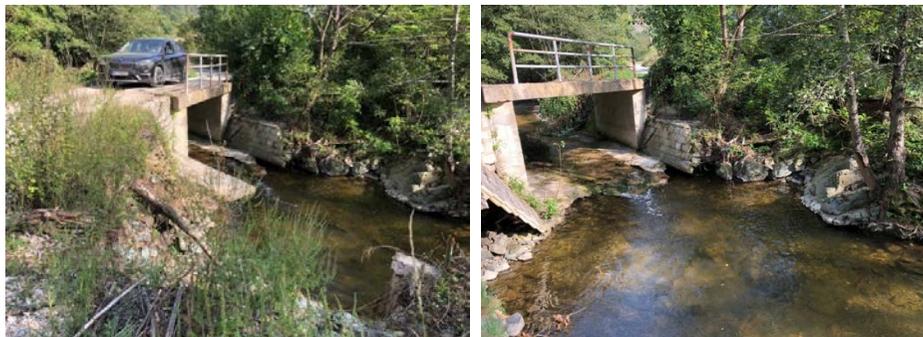
Figure 1. Bridge over Paklešnice River cadastral plot no. 2339

The existing bridge is constructed as a reinforced concrete bridge positioned at angle in relation to a water barrier, in one opening, a system of simply supported beam - slab with span of approximately $l = 7.73$ m (clear span between the abutments $l = 7.32$ m), Figure 1. The deck slab of the bridge at both ends is supported by the abutments of the bridge without specially designed transversal support beams. The deck slab is RC slab, thickness approx. $d = 35,0$ cm made on site. The existing width of the bridge perpendicular to the span is $b = 4.20$ m, without pedestrian paths.

BRIDGE 1 - existing main and distribution steel ($\Phi 18 / 15/30$; $\Phi 6 / 20$) do not meet the required calculated reinforcement, therefore it is necessary to repair the deck slab in both directions.

The rehabilitation of the bridge is predicted in that way that the pedestrian paths are supported by new reinforced concrete girders with "G" cross-section, which are placed on the vertical abutments, that are supported by the expanded and reconditioned existing foundations, Figure 5. At the height of the supporting beams, reinforced concrete wing walls are designed to form the revetment of the embankment and connecting the pedestrian path to the existing embankment. Foundation is envisaged so that the existing foundations of the wing walls are underpinned and laterally expanded to accept new vertical reinforced concrete pillars (the supports for newly added laterally placed reinforced concrete beams-pedestrian paths) in all according to the conditions obtained from the geomechanical study.

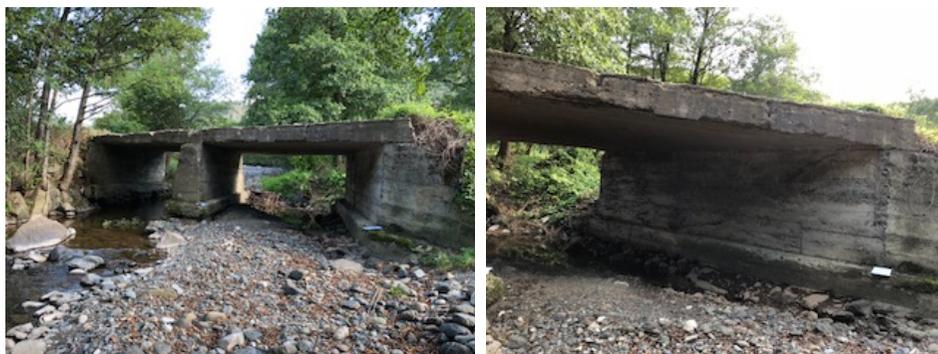
Figure 2. Bridge over Paklešnice River near Šujdović's house

The existing bridge is constructed as a reinforced concrete bridge positioned at angle in relation to the water barrier, in two openings, with a supporting abutments, Fig. 2. The static system of the deck slab is two simply supported beams - slabs with spans approximately $2 \times l = 5.97$ m (an opening between middle pier and abutments $l = 5.57 - 5.59$ m). The deck slab of the bridge is supported by the abutments and the middle pier, without specially designed transversal support beams. The deck slab is RC slab, thickness approx. $d = 40,0$ cm made on site. The existing width of the bridge perpendicular to the span is $b = 5.52$ m, without pedestrian paths.

BRIDGE 2 - the existing main steel ($\Phi 18/15/7.5$) meets the newprojected loads ($A_{ax} = 17.04 \text{ cm}^2$, which is larger than the required reinforcement $A_{ax} = 11.50 \text{ cm}^2$), therefore there is no need for rehabilitation in this direction. However, the existing distribution steel ($\Phi 10/20$) does not meet the required calculated value of the reinforcement ($A_{ay} = 3.95 \text{ cm}^2$, and the new load $A_{ay} = 5.62 \text{ cm}^2$ is required), therefore it is necessary to repair the deck slab in the y direction.

The rehabilitation of the bridge is foreseen so that the pedestrian paths are supported by new reinforced concrete girders with "G" cross-section, which are placed on the vertical edge abutments, that are supported by the expanded and reconditioned existing foundations, Figure 6. Due to the considerable visual damage of the upper surface of the deck slab a partially removal in a thickness of approx. 7.0 cm was predicted, as well as a part of the edge slab in the width of 20 cm. The removed part is cleaned under the pressure of the air in order to make connection between the old and the new concrete, which is performed in an additional thickness of 8 cm, therefore the rehabilitated part of the slab has a total thickness of approx. 15.0 cm. The appropriate reinforcement is installed in the upper zone of the rehabilitated slab. The connection of the old and new part of the slab is achieved by the installation of a certain number of anchors epoxied.

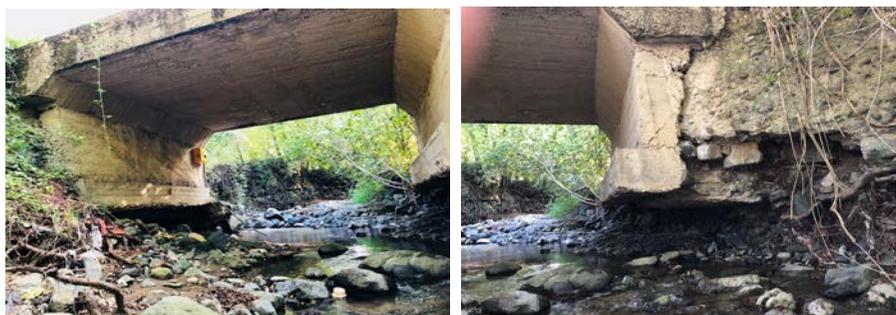
Figure 3. Bridge over the Kravarički brook near the Forestry House

The existing bridge is constructed as a reinforced concrete bridge positioned at an angle in relation to a water barrier, in one opening. The static system is simply supported beam-slab of a span approximately $l = 5.56$ m (clear opening between the abutments $l = 5.17$ m), Figure 3. The deck slab of the bridge at both ends is supported by the abutments of the bridge without specially designed transversal support beams. The deck slab is RC slab thickness approx. $d = 36,0$ cm made on site. The existing width of the bridge perpendicular to the span is $b = 4.62$ m, without pedestrian paths, with edge beams 18 cm above the carriageway.

BRIDGE 3 - the existing main steel ($\Phi 18/15$) meets the newprojected loads ($A_{ax} = 17.04 \text{ cm}^2$, which is larger than the required reinforcement $A_{ax} = 13.29 \text{ cm}^2$), therefore there is no need for rehabilitation in this direction. However, the existing distribution steel ($\Phi 10/20$) does not meet the required calculated value of the reinforcement ($A_{ay} = 3.95 \text{ cm}^2$, and the new load $A_{ay} = 10.23 \text{ cm}^2$ is required), therefore it is necessary to rehabilitate the deck slab in the y direction.

The rehabilitation of the bridge is foreseen so that the pedestrian paths are supported by new reinforced concrete girders with "G" cross-section, which are placed on the vertical edge abutments, that are supported by the expanded and reconditioned existing foundations, Figure 7. At the height of the supporting beams, reinforced concrete wings are designed to form the revetment of the embankment and connecting the pedestrian path to the existing embankment. Foundation is envisaged so that the existing foundations of

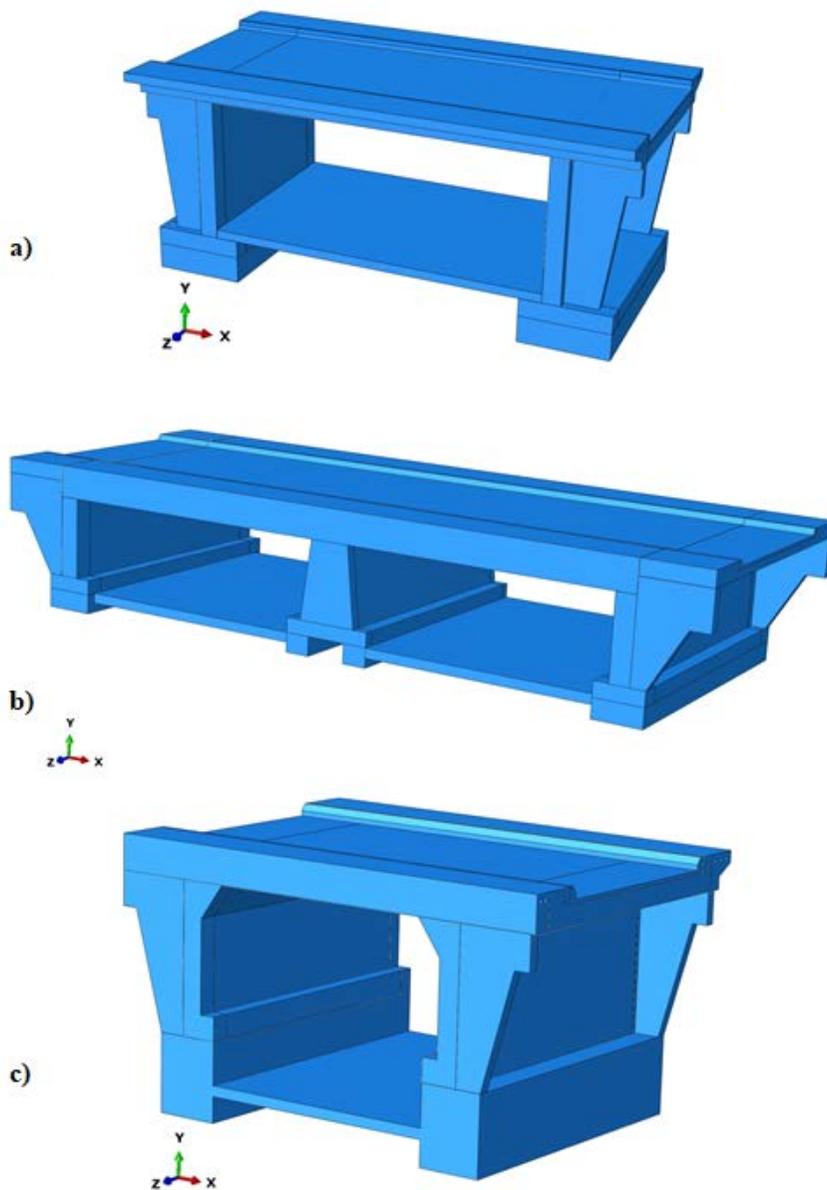
Figure 8. 3D numerical model for: a) BRIDGE 1; b) BRIDGE 2; c) BRIDGE 3

Numerical model of the bridge structure and the loads presented in this paper were prepared in the ABAQUS software as given in the Figure 8. The model is based on 3D finite element modelling. In this way, a real picture of the stress states and deformations at all points, as well as the internal forces required for dimensioning of the elements of the bridge construction was obtained. The material is modeled as elastic and isotropic for all elements, that is, with the characteristics of the materials that correspond to the quality of RC given in Tables 1 and 3.

The bridges' models consist of a RC slab supported by the abutments that are rigidly connected to the foundations. Also, the connection between the vertical edge pillars and the abutments was achieved by a rigid connection. The supports are modeled as surface, with no movement in X, Y and Z direction.
