THE SECOND STAGE SANATION OF THE LEFT SIDE OF THE BAJINA BASTA DAM

Summary: *The Bajina Basta Dam is a hollow gravity dam. It was completed in 1966. In the previous period, due to the occurrence of cracked systems, the Project to repair the left side of the dam was made in 1992. The first phase of rehabilitation was completed in 2006. However, tangential displacements do not have a tendency of stopping. For that particular reason, an additional analysis of the problem of the dam was performed. The second phase of repair refers to blocks No.19 and No.20.*

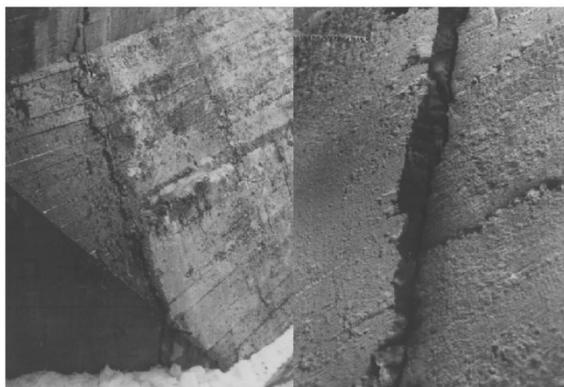
Figure 2. Cracks

The cracks in the dam buttress walls have appeared in the blocks No.20 and No.21 of the left abutment and were observed during 1987. In the block No.21, the main crack has the widest opening at the foundation zone and the crack path follows the trajectory of the maximum tensile stress. The cracks are extended through the entire block section. The cracks in block No.20 are located on both buttress walls.

- It was concluded that the cracking causes cannot be the usual loads combined with temperature and heat effects. The fact that no cracks have occurred in the central blocks, whose height and length are greater than the analysed ones.
- Rock displacements are transmitted to the dam in lateral direction. The primary displacement of the foundation strata is constrained by the dam acting, which is in this case, a strut. The left abutment is founded on melaphyre, which is a much more rigid rock than the underlying shales.

A solution of the sanction has been adopted which accepts and reduces to the minimum the effects which causing the cracks. Filling of the blocks bottom zones with mass concrete is applied. The new concrete is joined with the old to form a rigid beam. This composite beam is made with pre-stressed cables and grouting of the joints between old and new concrete. The homogeneous beam formed is intended to receive future displacement influences equal to the maximum observed so far. Mass concrete continuous fill reduces the eccentric interaction between blocks. Each block bending is received by the formed composite beams. Finally, the possibility of relative movement between adjacent blocks is reduced. The total concrete and reinforcement bearing capacity is used.

In addition to this filling, the buttress wall of block No.21 is also lined with new concrete, on both sides of the buttress wall, with thickness of 1.00 m, which is as well connected to the old concrete, and which have the function of securing already cracked locations and eliminating the progress of existing cracks under additional loads.

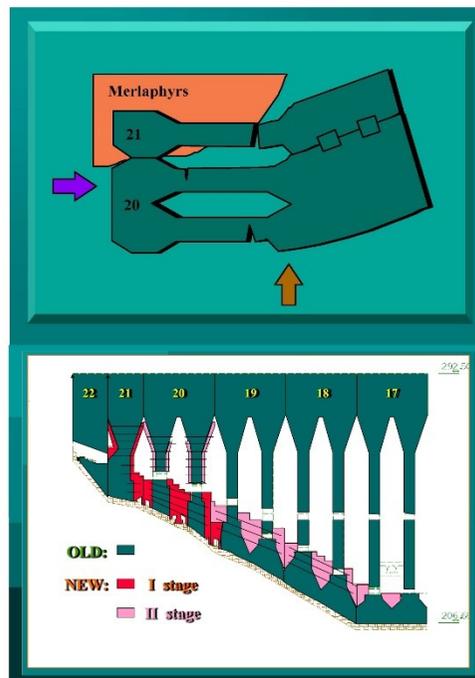
Figure 3. Deformation model and Stages of the sanitation

- Likewise, the joint action of the three lateral dam blocks, connected at their downstream ends, causes block bending during horizontal displacements. The left dam abutment supported by the degraded zone of the Palaeozoic and melaphyre rocks contact, in asymmetrical position to the dam axis, is in unfavourable condition. Melaphyre is, unfortunately, located eccentrically with respect to the dam axis. It is clear that under such conditions these movements must cause lateral bending of the dam blocks.
- The stability analyses of full hydrostatic pressure and possible seismic loading case showed considerable differences of the stability coefficients. In this

particular case, it is clear that the possibility of force transmission exists due to different block displacements.

- That tangential displacements do not have a tendency of stopping but however they have a quasi-continuous increase.
- By analysing possible further spreading of cracks in the dam, it has been ascertained that there is a chance of formation of a kinetic mechanism, whose displacements could endanger the stability of the left abutment blocks and, consequently, the stability of the whole dam.

According to the previous Project, it was considered to carry out the repair in three stage. In the first stage, filling of the blocks bottom zones (the interspace between blocks No.20 and No.21) with mass concrete is applied. The block No.21 is also lined with new concrete, on both sides of the buttress wall. In the second phase, filling the space in block No.19 and the cheeks on block No.20 would be performed.

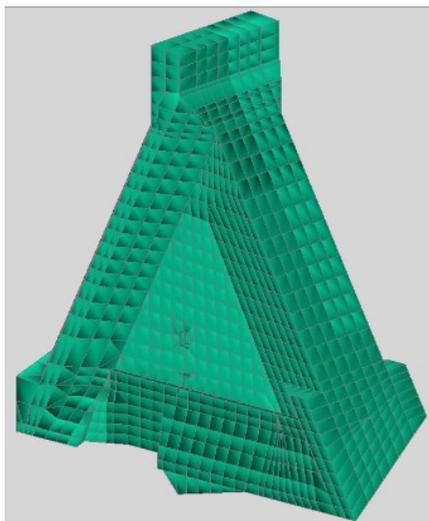
Figure 4. FE model

The analysis of the obtained results shows that there is a coincidence of the maximum tensile stresses with the actual crack locations on the block. According to computation, the maximum tensile stress amounts to 4,02(3,81) MPa, which is higher than the tensile strength. Comparing the data obtained from the numerical models with the condition of the dam and with current measurements, it was concluded that it is necessary to continue with the repair, so that the dam could be fully functional and absolutely safe. The second phase of repair refers to sections No.19 and No.20.
