REHABILITATION-UNDERPINNING OF OBJECT DUE TO REMOVAL (DEMOLITION) OF GROUND FLOOR COLUMNS

Summary: *Due to new use of the building, it was necessary to remove 6 pillars of the ground floor, whose demolition has to ensure the uninterrupted functioning of the places in object above ground. The existing building has ground floor, first floor and attic. Bear loading structure is combination of reinforced concrete columns (middle part) and vertical and horizontal reinforced concrete elements which are located in facade walls. First floor slab is made from LMT brick elements, which are resting on the longitudinal reinforced concrete beams. Instead of the removed columns a steel I-girders of two different spans ($l=12.40\text{m}$ and 10.60m) were places in transverse direction. Girders were made from two I-beam interconnected in levels of top and bottom flanges. These new girders, which upheld the upper floor structure, are resting on new reinforced concrete columns. New columns are built in axes 3'/C, 3'/D, 3'/E, and in 1/C,1/D, 1'/E. The spatial stability of the newly designed structure is provided by bracing in the level of the upper flange of new steel crossbeams. Reinforced concrete

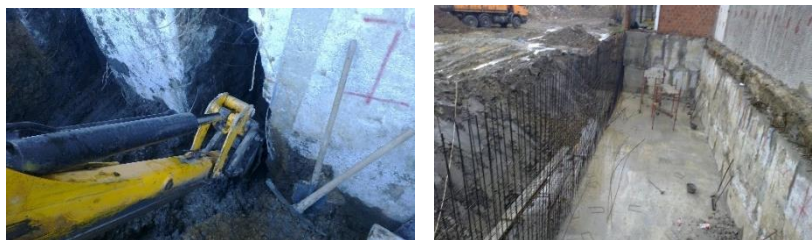
Figure 2. Under concreting and excavation of facade wall in axis 4.

Due to high underground water level under concreting of wall was finished in two height stages with parts wide 100-120cm. After finished first phase concreting a combined mechanical-hand excavation started. During all phases of concreting lowering of groundwater was done in order so that work could be carried out in the dry conditions. Figure 2. shows phase excavation works.

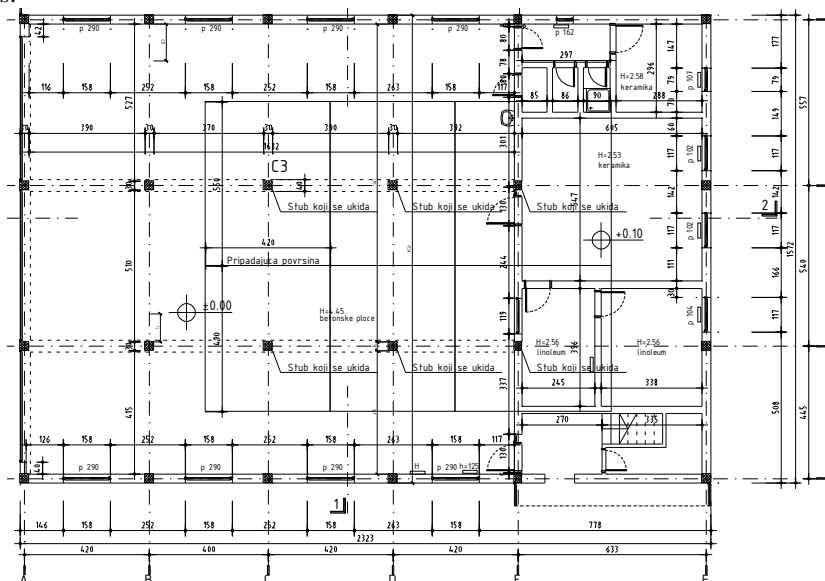
Figure 3. Ground floor plan columns that are removed (C2, D2, D3, C3, E2 and E3)

Figure 3. shows ground floor plan with marked columns that are removed-demolished. Figure 4. presents cross section of the building with structure for underpinning of upper floors.

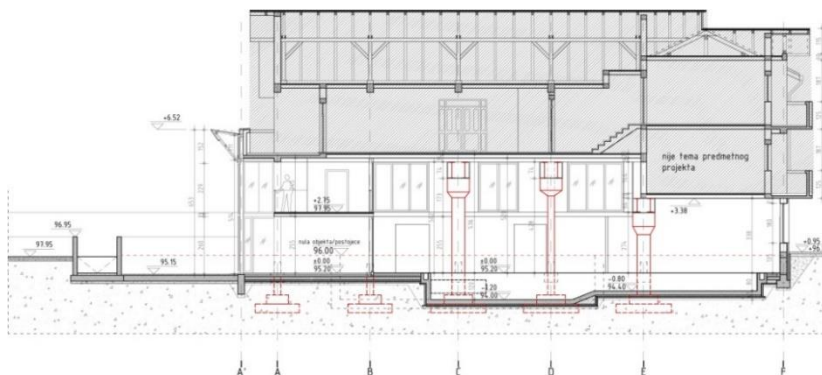
Figure 4. Location of new columns and steel beams for the building underpinning

Newly designed structure which support building floor and attic was made from steel I-girders and reinforced concrete columns. Support reactions, at the place of the removed (demolished) pillars, are submitted as concentrating forces on transverse bearing frame system. This was made possible because of the existence of longitudinal beams in the axes 3 and 4. First floor slab, which is made from LMT brick elements, rests on the longitudinal reinforced concrete beams and façade walls ring beams.

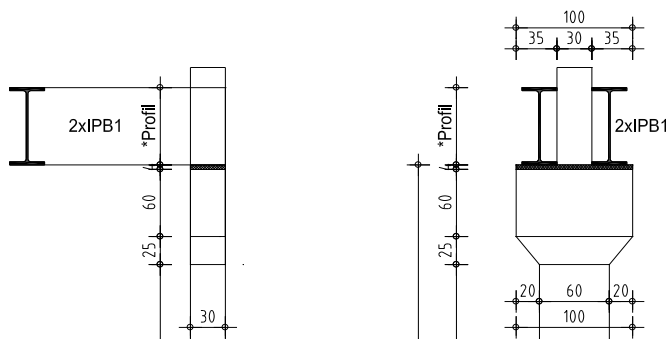
Figure 5. The capital of the new RC-column and steel I-beams for underpinning the building

Influences on the new steel beams are determined based on the force acting on the top of the column which is removed. New steel I-beams rests on the capital no top of the new reinforced concrete columns. Under steel IPB1-700 beam bearing plate was placed and concreted with special high strength fine-grained concrete Sika Grout 212. (Shaded part on Figure 5.). Columns were designed using recommendation from [1] and [2].

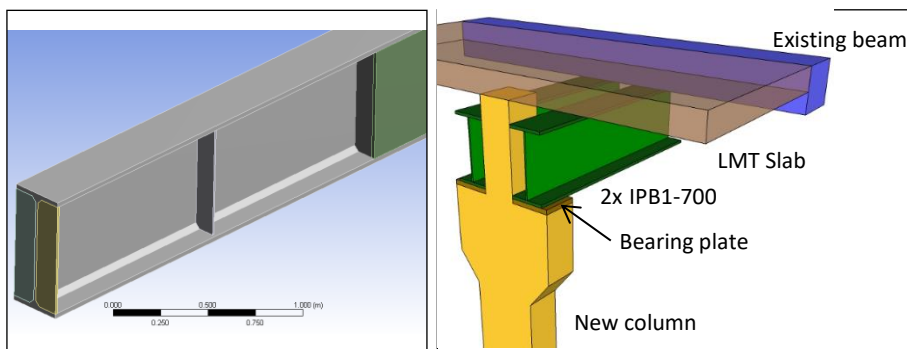
Figure 7. Steel beam with stiffeners and added plates, RC column with capital

A steel girder is composed of two hot rolled steel I-beam strengthened by two side steel plates and cross placed steel stiffening plates (Figure 7. left). Additional strengthening by two vertical 2#636×20 steel plate was done in the middle part of the girder. Determining factor for dimensions of transverse steel girders and steel plates was deflection of beam. Upper floor needed to be without any influence of the settling or deformation of lower parts of the building. Composite action was considered as in [3].

Permanent load (g) vertical deflection was $u=19.9mm$ which gives ratio of deformation of $10400mm / 19.9mm = 523 \rightarrow l / 523$.

Total load (g+p) deflection $u=23.3mm$ gives ratio $10400mm / 23.3mm = 446 \rightarrow l / 446$

Thus cross-section meets the established deformation criteria of $l / 300$.

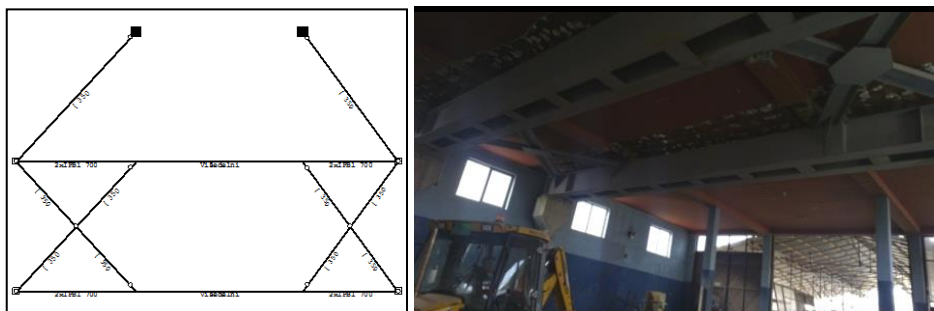
Figure 9. The spatial model and constructed support-bracings

The transverse stability of the new frame was, in static sense, constrained columns with hinged connection to steel girders. Longitudinal stiffness was achieved by placing the rigid stiffener in the form of braces formed from the hot-rolled steel U-profile, as it was presented on figure 9.

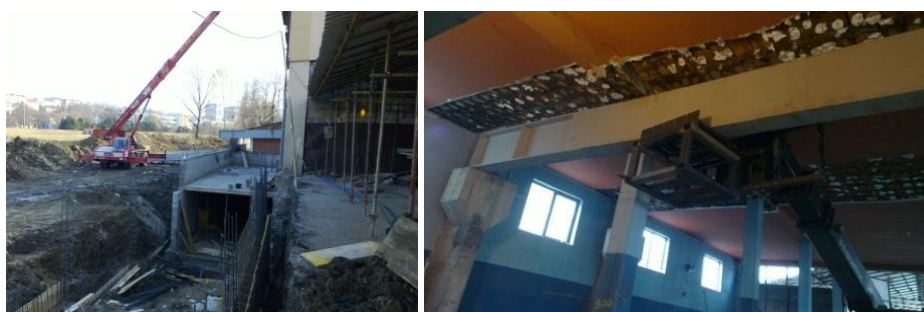
Figure 10. Excavated basement and placing of the steel I-beams

The most complicated part of the execution of underpinning existing structure floors and the attic is a way of execution and methods-phases of construction. In the project first planned operation was execution of underpinning of longitudinal RC beams around columns, and then demolition of the existing columns, walls and foundations. The first carried out operation on the object was making of a new reinforced concrete columns with capitals. Preparation of steel I-beams was carried out in the workshop and then pair of I beams were then transported to building site. Lifting and carrying of I-steel beams outside the building was performed by auto crane. Transport inside the building was carried out by two smaller portable cranes (Figure 10.).

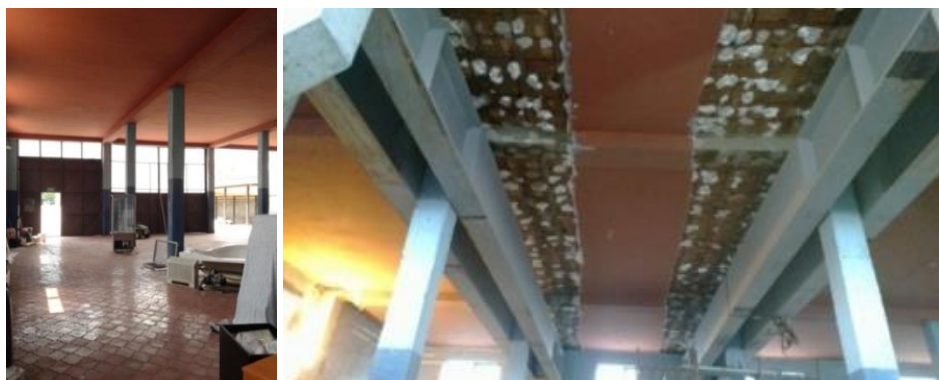
Figure 11. Existing columns for demolition and new steel girders

Figure 11. shows existing columns that are chosen for demolition and already raised steel I-beams before their connection. Beams were then interconnected with steel plates.

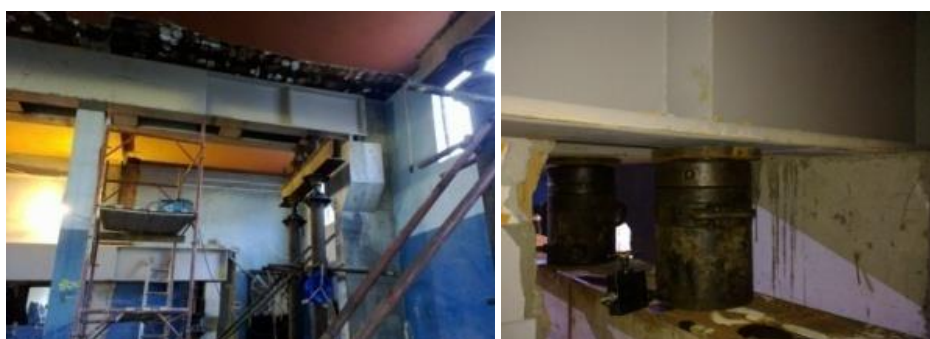
Figure 12. Lifting of steel girders by hydraulic presses

On the temporary supports spacers are placed and pouring of the same material was also performed under the steel beams. Before these operations, frames with presses are set, and force was entered in areas near supports on reinforced concrete columns. Figure 12. shows temporary frames and hydraulic presses for uplifting the steel beams.

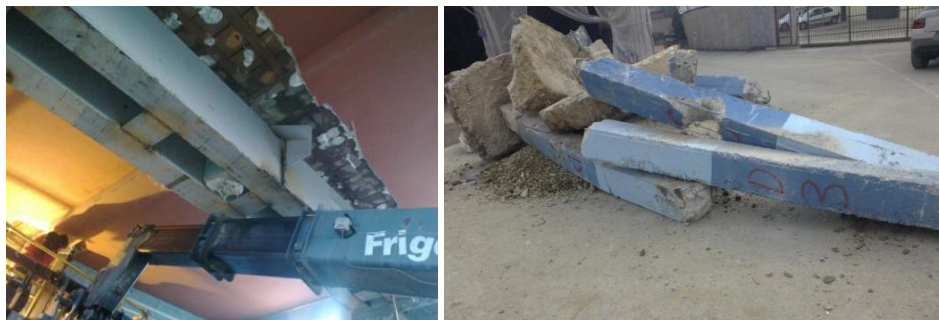
Figure 13. Demolished columns

After curing the grouting mixture, the demolition of existing columns was carried out, as shown in Figure 13. Columns were cut off just below steel beams and then removed from building. New steel-RC frame then took over the load from upper floors.

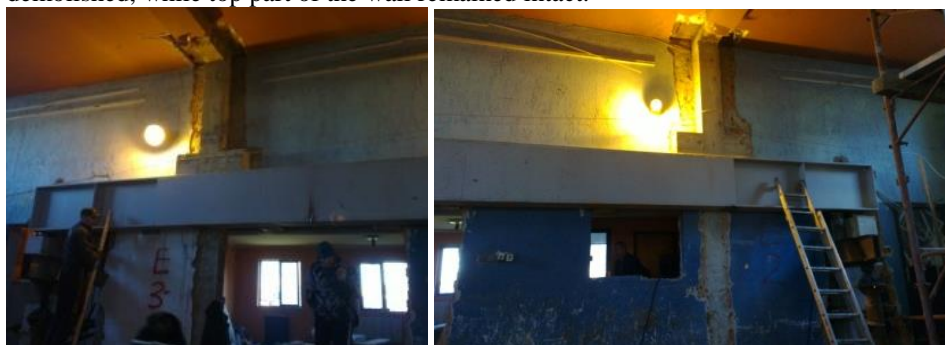
Figure 14. New short columns on top of the new steel I-beam

Special curiosity are the so-called "hanging supports" e.g. supports formed from short RC columns created under existing reinforced concrete beams and on top of the new steel beam. Figure 14. shows columns on top of the steel beam. Wall under that beam was also demolished, while top part of the wall remained intact.

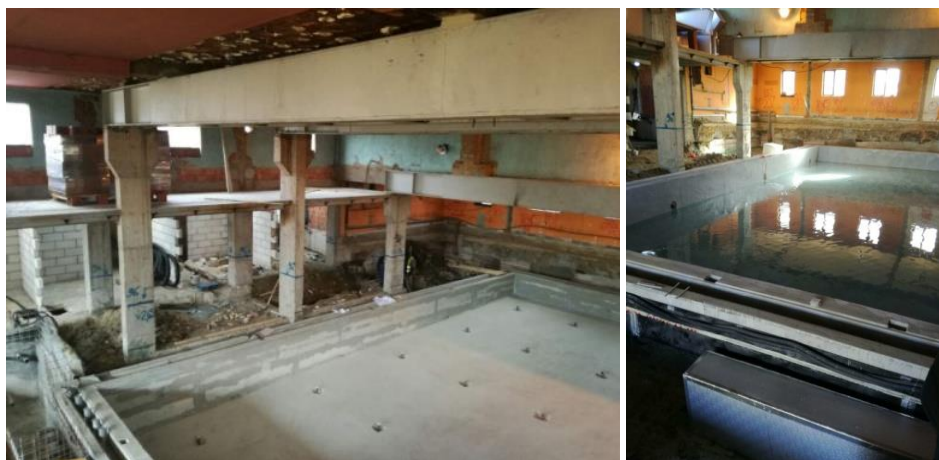
Figure 15. The inner part of the building with the newly designed structure and pool

Figure 15. shows the structure of the galleries and the functional part of new purpose of the building. New shallow swimming pool was build and partially filled with water.
