## STRUCTURAL REHABILITATION OF HISTORICAL MASONRY BUILDINGS IN ROMANIA

*Summary:* The paper is focused on the analysis, redesign and rehabilitation solutions applied for old existing structures in seismic zones. The old malting building, erected between 1857-1876 at the "Timisoreana" Brewery, is a five storeys masonry structure and a tower composed of: walls of (140-50) cm thickness; inter-storey floors - brick masonry vaults supported by steel profiles; a tower, of about 14 m height and 2.80 m diameter, supported by an interior dome. The main structural damages were: vertical cracks in the tower masonry structure; corrosion of steel members – horizontal circular rings for confining the tower; steel profiles for supporting the floor masonry vaults. The static and dynamic analysis at different actions showed up major structural vulnerability, mainly due to the period of design and erection (19<sup>th</sup> century). In order to preserve the old building as architectural monument and to reduce the seismic failure risk, some strengthening solutions were designed and applied. The strengthening solutions were selected in order to obtain technical and economical advantages: safe behavi

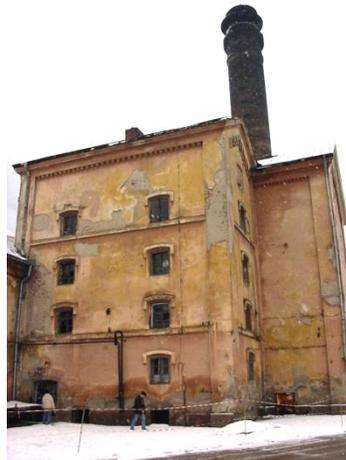
The old malting building, erected between 1857-1876 at the “Timisoreana” Brewery, is a five storeys masonry structure and a tower (Figure 1) composed of:

- walls of (140-50) cm thickness;
- inter-storey floors - brick masonry vaults supported by steel profiles;
- a tower, of about 14.00 m height and 2.80 m diameter, supported by an interior dome.

Figure 1. Old malting building

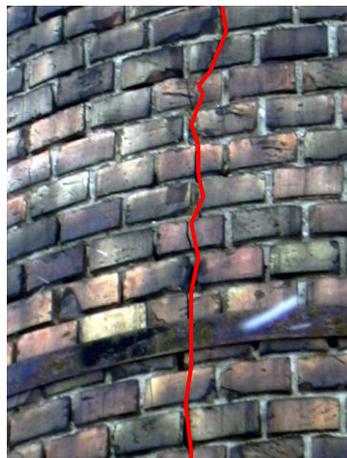
- vertical cracks in the tower masonry structure (Figure 2);
- corrosion of steel members: horizontal circular rings for confining the tower; profiles for supporting the floor masonry vaults.

Figure 2. Vertical cracks of masonry tower

- temperature variations inside-outside the tower produce actual stresses  $\sigma_t = 1.0 \text{ daN/cm}^2 > R_{ti}$  which causes the vertical cracking.

- for general stability of masonry tower: vertical reinforcement (*Figure 3*) bars (4 x 2 $\phi$ 28) embedded at the upper side of the tower in a RC beam (*Figure 4*) and welded on steel profiles (*Figure 7*) I 30 placed in the dome, at the tower base (*Figure 5*); vertical CFRP wrap (4 x 2 strips of 20 cm width) on the entire tower height (*Figure 3*);

- in masonry structure, at zones with stresses greater than masonry tensile strength, were placed horizontal RC straps: at the tower – dome crossing (*Figure 3*); at the base of dome; at the level of steel profiles I 30 network (*Figure 5*) for its embedding into vertical masonry structure;
- on the vertical cracked tower: corroded circular steel rings for confining the tower

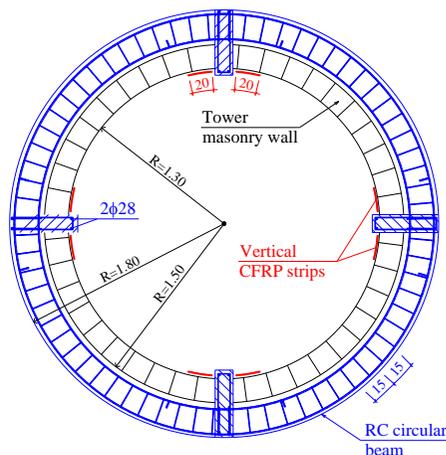
*Figure 3. Tower strengthening at base section*

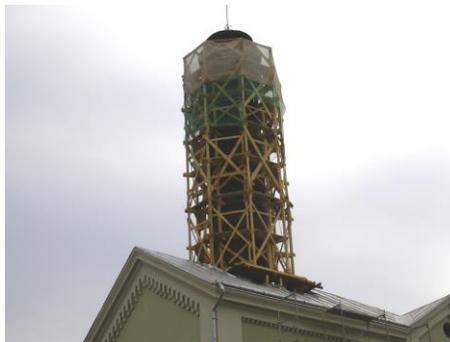
*Figure 8. Strengthening of tower structure*

The old malting building at the “Timisoreana” Brewery was firstly repaired and rehabilitated. Than, in 2008, the masonry tower structure was strengthened (*Figure 8*).

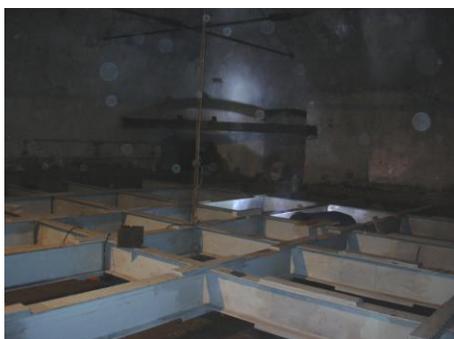
*Figure 9. Steel beams network*

In the dome, at the tower base was placed the steel beams network (*Figure 9*) and embedded in the masonry walls by means of reinforced concrete straps (*Figure 10*).

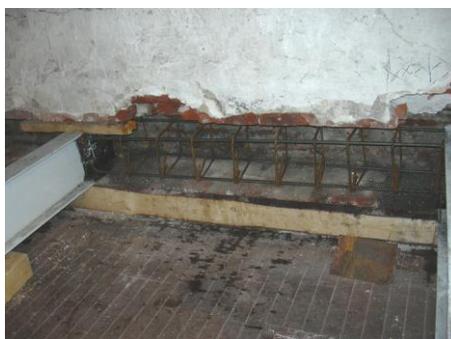
*Figure 10. RC straps for steel beams embedding*

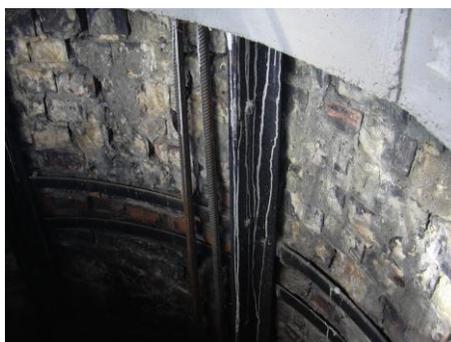
*Figure 11. Vertical rebars and CFRP strips*

The general stability of masonry tower was ensured by vertical reinforcement bars and vertical CFRP wrap on the entire tower height (*Figure 11*).

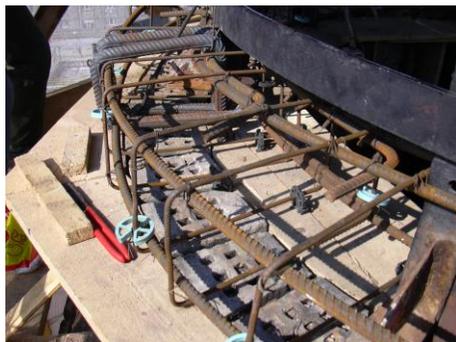
Figure 12. Reinforcing of the tower top beam

Vertical reinforcement bars were embedded at the upper side of the tower in a reinforced concrete beam (*Figure 12* and *Figure 13*) and welded at the bottom side on steel profiles from the tower base.

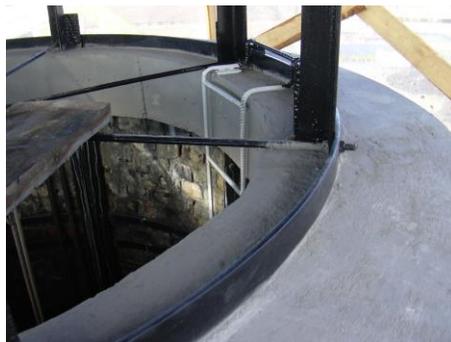
Figure 13. Reinforced concrete top beam
