## ORGANIZATION OF BRIDGE LOAD TESTING: RECENT EXPERIENCES

*Summary: Bridge Load Testing, in addition to the technical part, is closely related to the solution of organizational tasks, especially in the case of large and dilapidated structures during short time for test preparation and execution. In the paper, on examples of extensive and demanding tests of significant bridge structures, possible requirements and appropriate organizational solutions are presented.*

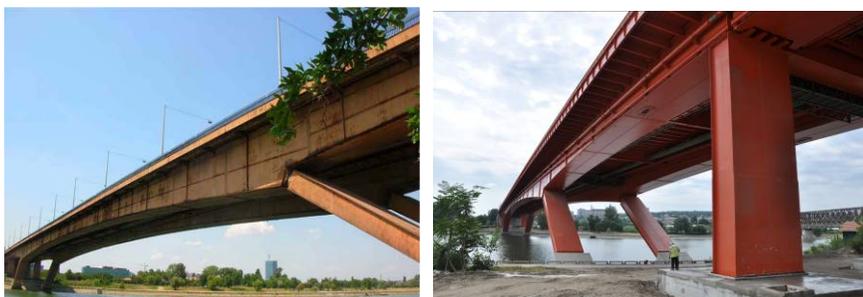
Figure 1. *Gazela bridge before and after reconstruction*

After more than 30 years of exploitation of the *Gazela bridge*, figure 1, on the part of the E75 highway through Belgrade, according to identified significant damages and requirements for strengthening of the structures within the bridge, during the period July 2011 - August 2012, extensive reconstruction works were carried out. The construction works were performed with the reduction of traffic, because that complete suspension of traffic which were not possible due to the importance of the part of the E-75 highway through Belgrade.

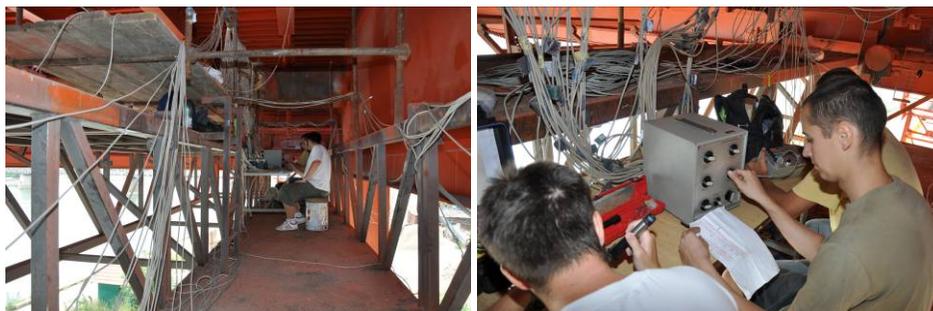
Figure 4. Main structure of Gazela bridge – preparation for strain measurements

In a short time of about 30 days, parallel with the partially installation of instruments, it was necessary to procure a large amount of necessary repro-materials (strain gages, adhesives, cables, etc.) under conditions of uncertain delivery time of importing components and lack of manufacturer / supplier stock (e.g. appropriate cables).

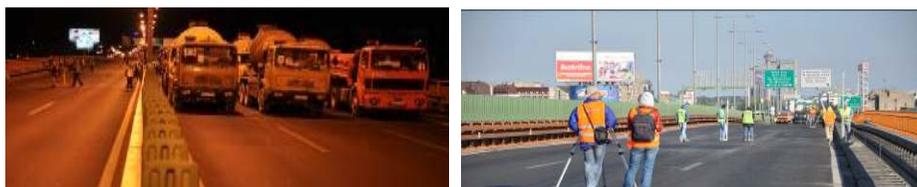
Figure 4. Survey measurements during Gazela bridge main structure load test

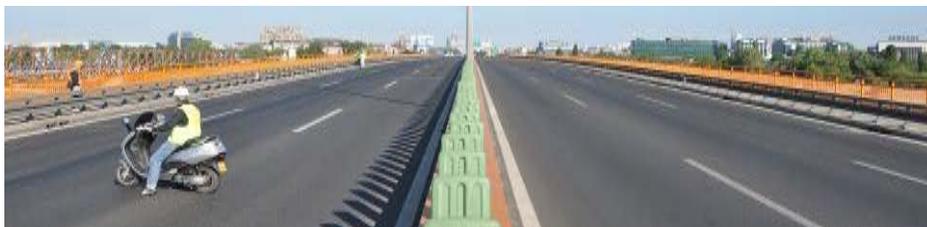
Figure 6. Survey measurement points and level measurements during of Gazela bridge main structure load test

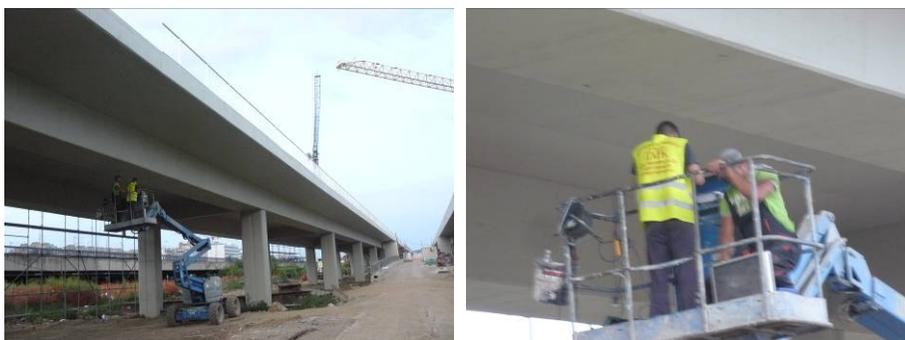
The testing of all viaduct structures was carried out after the completion of the asphalt cover, immediately after the installation of protective fences and barriers. The favorable circumstance was the fact that it was possible to pre-install a part test instruments, which includes installation of strain gages and partial cabling (installation of cables for connection with the acquisition system on some structures), figure 8. Also, it is possible to approach underneath the structures, because of the absence of obstacles (river, etc.), which significantly influenced to the conditions of execution load testing of bridges.

*Figure 8. Preliminary installation of instruments on part-ZS\_right\_lane of the viaduct*

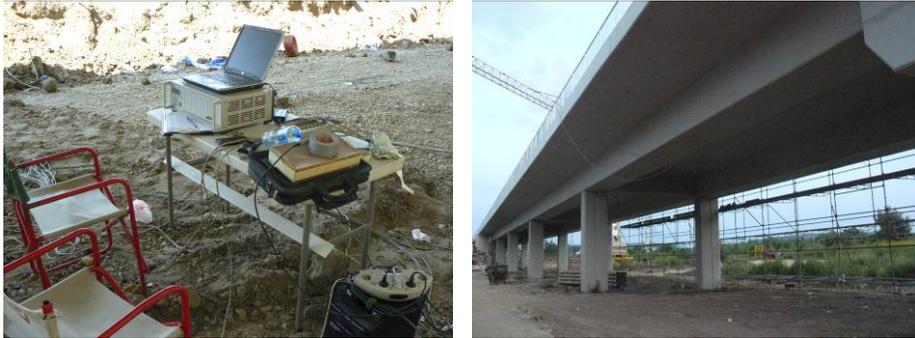
Regard this fact, since there was the possibility of installing electronic displacement measuring instruments and acquisition systems under the bridge, the tests were significantly accelerated. The choice of the method of displacement measurement using electronic instruments proved to be very useful instead of the application of the geodetic method of deflection measurement as a significantly slower method, which in this case was not necessary.

Figure 9. Acquisition system underneath of multi-span bridge structure

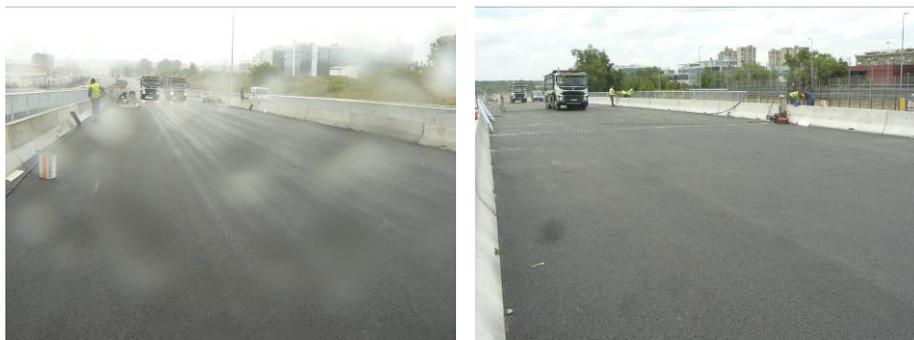
Figure 11. Bad weather conditions during testing execution with other activities

The applied organization of extensive testing of the multi-span structures, with occasionally bad weather conditions and parallel execution of some finishing construction works on secondary bridge elements, figure 11, provided possibilities to achieve predicted dynamics testing, and all tests carried out with the high reliability of the results. It should be noted that assumed layout of measuring sections for strain measurements avoided adverse effects of the use of long cables from strain gages, while the LVDTs are less sensitive to these effects, and all were simultaneously connected with the acquisition system. In the case of seven span bridges, at the same time were connected 14 LVDT instruments for simultaneous measurements.

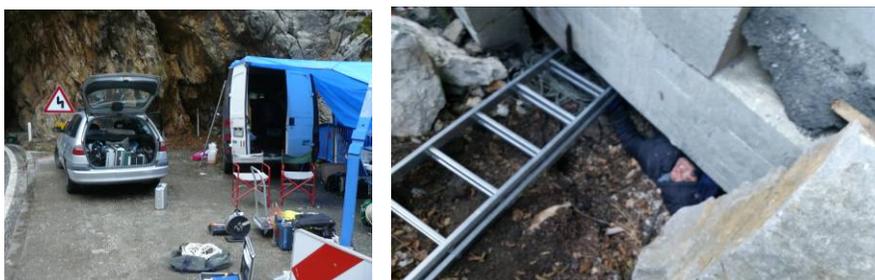
*Figure 13. Test section and test points of load tested Kostova greda bridge on section Šćepan polje – Plužine of the road M18 in Montenegro*

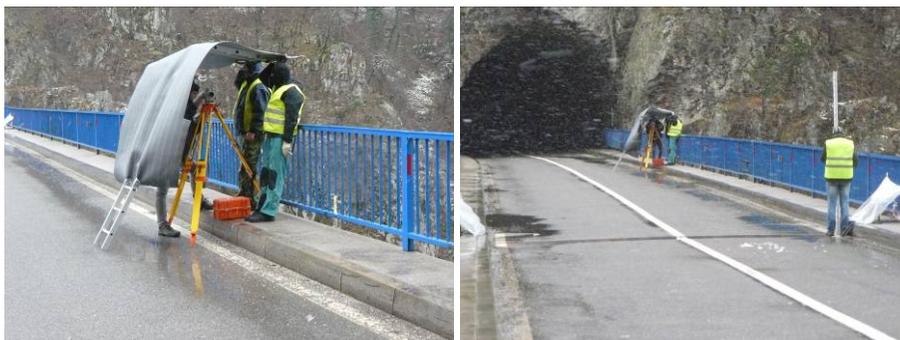
In order to carry out the test, suspension of traffic was provided twice during a day with duration of 3 hours each. During this time, it was required to perform the necessary geodetic deflection measurements of the structure using geodetic method in extremely unfavorable weather conditions. Surveying measurements were carried out in the presence of improvised protection, Figure 14, which ensured that measurements were performed within the short time and with a very good quality of the obtained results.

Figure 14. Geodetic measurement during load testing of Kostova greda bridge under improvised protection of snow and rain
