REMARKABLE BRIDGE CONSTRUCTIONS WITHIN THE REGIONAL DIRECTION OF ROADS AND BRIDGES TIMISOARA

The paper presents an overview of art constructions from DRDP Timișoara, with some remarkable examples.

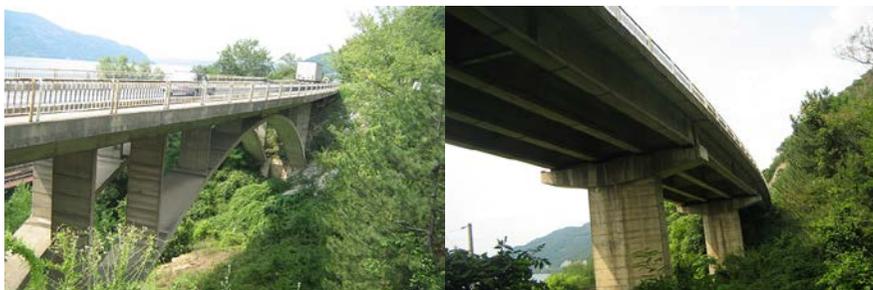
Figure. 1. Viaduct on DN 6 km 358+268; km 358+720

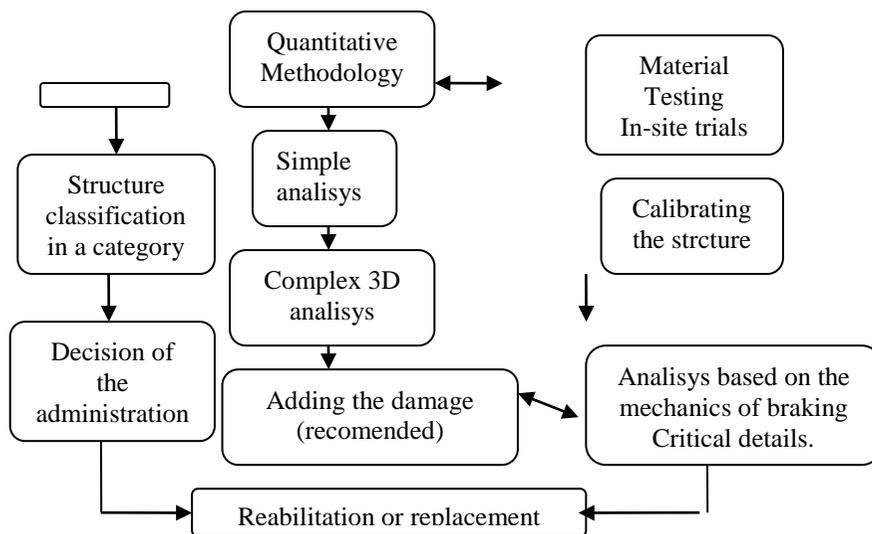
Figure 2. Methodology for verification of existing road bridges

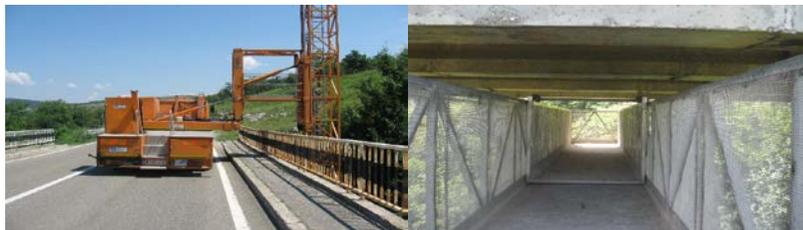
Fig. 2. (a) MOOG type bridge inspector (b) The working platform of the MOOG bridge inspector.

investigation and inspection of infrastructure and superstructure elements, but also for intervention and remedial works of degradation, the Regional Directorate of Roads and Bridges Timisoara has the MOOG type bridge inspector.
