METHODOLOGICAL APPROACH TO THE IMPROVEMENT OF THE PROTECTIVE STRUCTURES ON ARCHAEOLOGICAL SITES MEDIANA AND DRENOVAC

Summary: *The paper provides a multidisciplinary (archeological, architectural, structural and thermo-technical) methodological approach to improve the efficiency of protective structures from the mentioned point of view, at the locations of Mediana and Drenovac. The aim of the paper is to provide optimal architectural and structural solutions based on an analytical multidisciplinary approach related on measured micro-ambient parameters.*

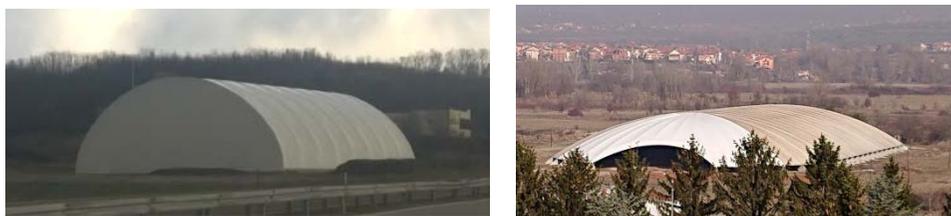
Fig. 1. Shelter on Drenovac (left), Shelter on Mediana (right)-under construction

settlement in „Drenovac”, and there are around a hundred other registered sites in the area of Pomoravlje area. The most interesting fact is that these settlements exhibited the oldest traces of animal husbandry and farming. The protective structure on this site was built in 2013 as arched system of glued laminated timber (span 30m, high 11m), having cylindrical form (length 40m). It is a fully closed structure with periodically small openings for longitudinal ventilation on frontal sides, covered by a PVC membrane. The basic purpose of this protective structure is a thematic research and conservation of the buildings, but it will have a touristic, educational and environmental dimension as well.

The ancient settlement erected near Niš is for the first time mentioned in IV century AD. It was declared an immovable cultural property of outstanding importance. The heyday of Mediana was during the reign of the emperor Constantine the Great. The settlement is famous for its residential buildings, and the complex also contains the auxiliary structures for the garrison, servants etc. The first registered data on the remains of the mosaics and buildings date back to Felix Kanitz from the end of XIX century, and the first systematic excavation began in 30's of the XX century. The most important building on the site of Mediana is the Villa with peristyle, which was in 2014 mostly covered by a protective structure. The structural system is composed of shallow arches supported on the massive eccentric foundation blocks. The span of the structure is 72,5m and the mutual spacing of the arches is 5m. The frontal parts have the form of semi-domes with radial semi-arches. The cover is a PVC membrane with the polyester core.

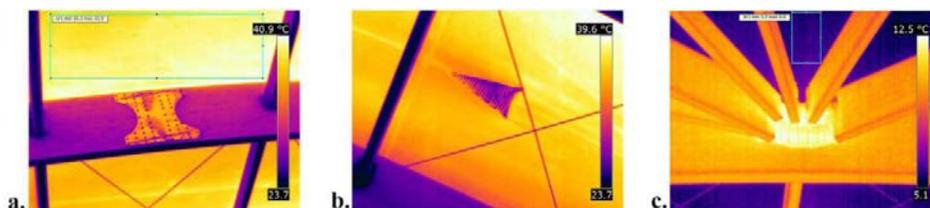
Fig. 2. a,c. GlueLam wood arches with metal connectors, b. Small vents on membrane roof

The cause of occurrence of moisture was investigated by the expert team from the Faculty of Civil Engineering and Architecture of Niš, starting from the preliminary assumptions on the moisture causes. The first assumption was that the condensation is caused by the structure of the arched beams, which due to the fitting technology were composed of three parts which were assembled in situ using metal plate connectors. (Figure 2.a). Metal and wood have different thermal characteristics, so it was assumed that condensation occurred on the metal surfaces of the connectors.

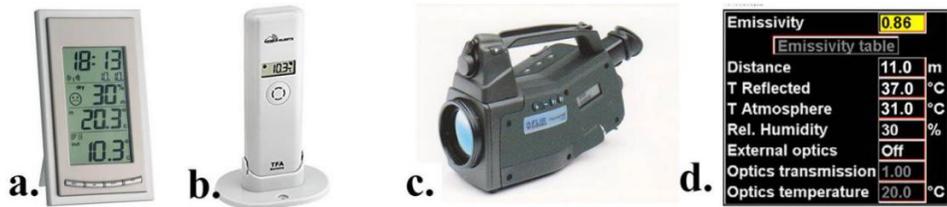
Fig. 3. a. Temperature/humidity station, b. Temperature Transmitter c. ThermoCam Flir B20, d. ThermoCam table with applied settings

After making assumptions, the research team made an investigation plan which comprised acquisition of data on temperature and relative humidity of atmosphere, using the meteorological station WeatherUnderground I20DONJA2, and by measuring the same parameters in the shelter, using TFA Dostmann wireless 868 MHz temperature/humidity station (Fig.3.a, b) Temperature of the surfaces which were assumed to have had condensation were measured using a thermal-vision camera ThermoCam FLIR B20 (Fig.3.c, d). It was decided to perform the measuring at times of daily maximum and minimum temperatures for 10 consecutive days (16/04 to 25/04/2018). The morning measurement was performed immediately before sunrise, at the moment when the external temperatures are the lowest, and the afternoon measurement at the time of day when the temperatures were the highest. The IR camera recorded the temperatures of the wooden beam, metal connectors, vents and membrane cover (Fig.2). Measurements were taken at nine points (A1-A4 and B1-B4, C). The points where surface temperature, air temperature and humidity were measured are presented in figure 4.

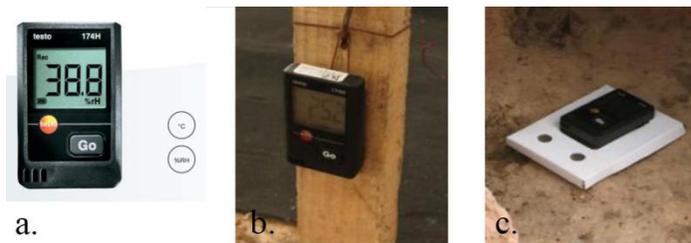
Fig. 7. Temperature/humidity station, a. Overview, b. Probe on level -2m, c. Probe in “Neolithic house” on level -2m covered by geo-textile
