DETERIORATION MECHANISMS OF NEW JERSEY BARRIERS ON HIGHWAY CORRIDOR VC SECTION ZENICA-SARAJEVO

Paper type: review paper

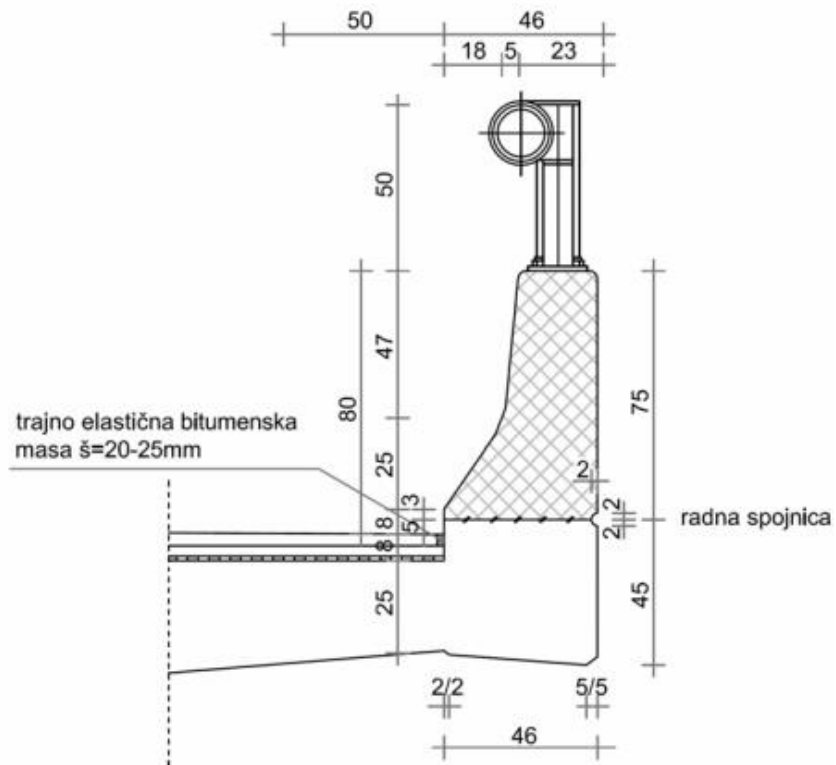
Figure 21 External monolithic New Jersey barrier - height 80 (110 cm) [5]

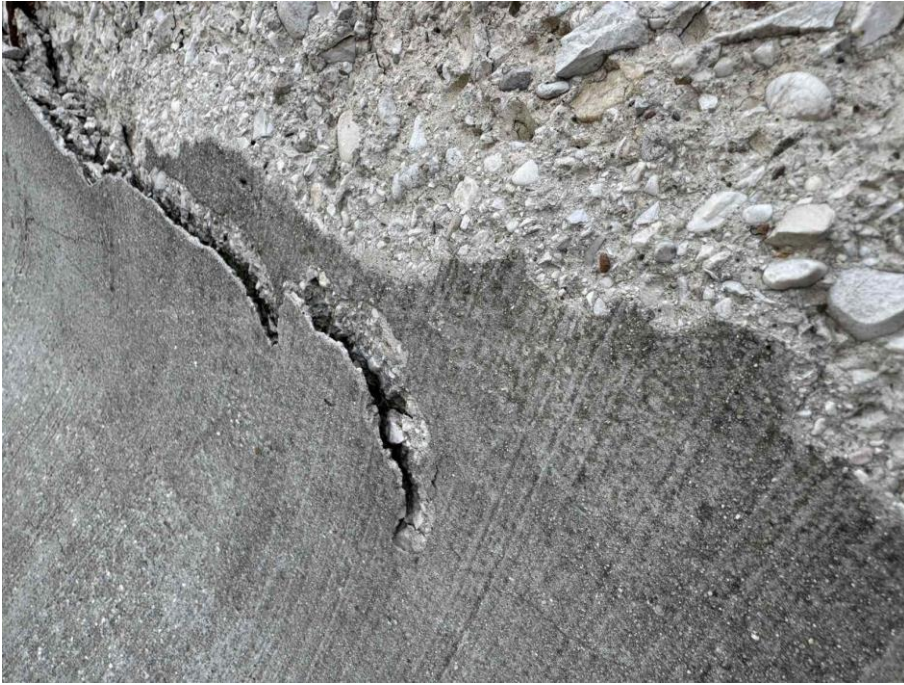
Figure 24 Diagonal cracking and edge separation caused by repeated vehicle contact and surface fatigue

Field observations and photographs reveal diagonal cracking and surface fatigue clear indicators of stress from repeated vehicular contact. Furthermore, slight separations at the joints were documented, suggesting that some of the damage extends below the surface and may indicate deeper structural movement.

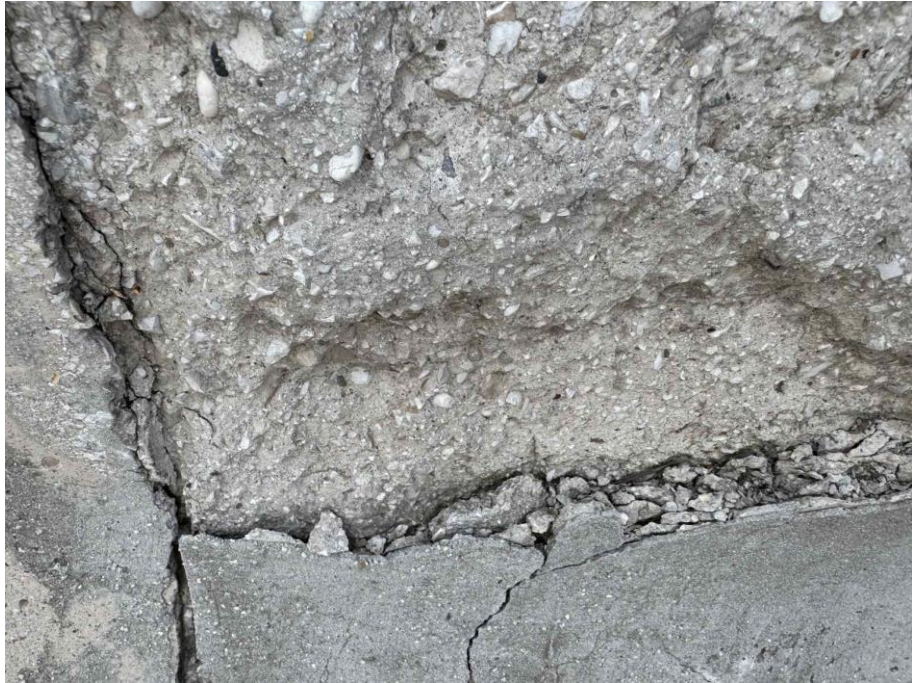
Figure 25 Cracking and minor joint separation suggest structural stress and possible construction-related defects

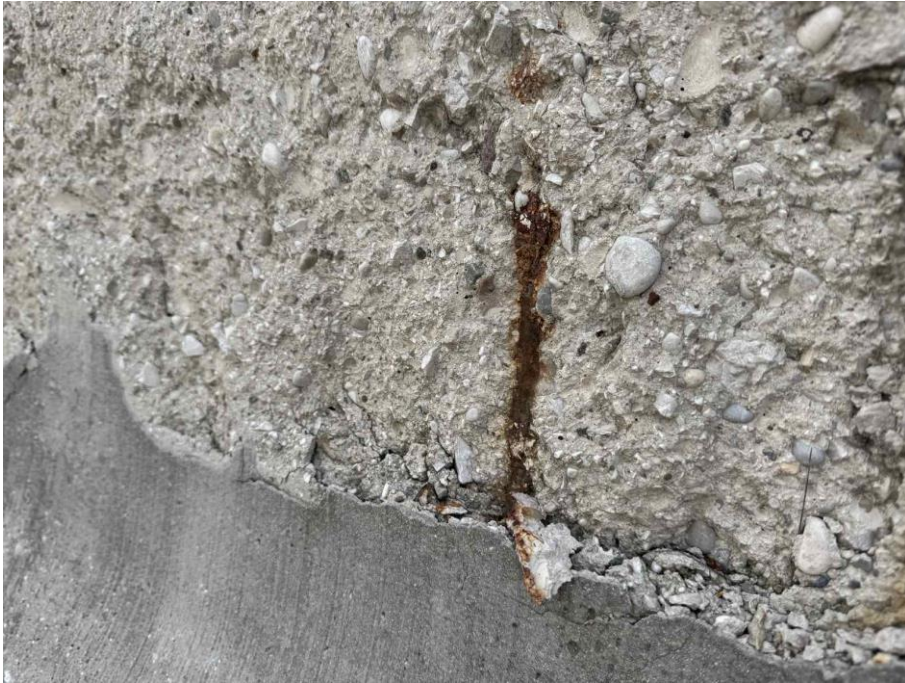
Once chlorides meet the steel, corrosion initiates. This process leads to the steel expanding, which generates internal stresses. As a result, the surrounding concrete begins to crack and fracture. Field inspections have revealed surface staining and rust marks both classic indicators of ongoing corrosion. In several cases, spalling had advanced to the point where corroded rebar was exposed, clearly demonstrating the extent of chemical damage in those areas.

Figure 26 Evidence of corrosion-induced staining embedded steel reinforcement, indicating chloride ingress and carbonation

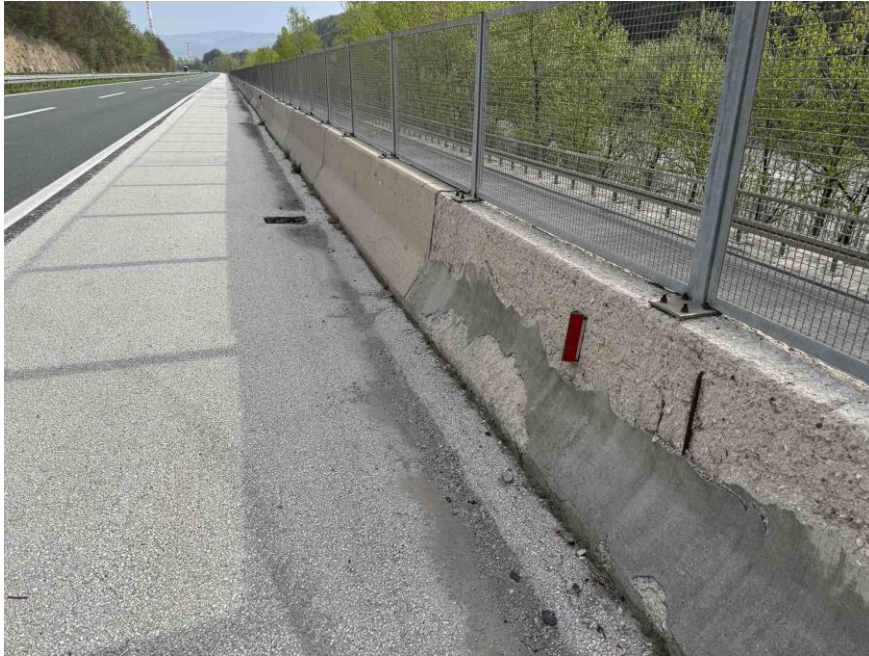
Figure 28 General view of deterioration New Jersey barrier showing large areas of spalling, surface scaling and reinforcement exposure near high-traffic segment

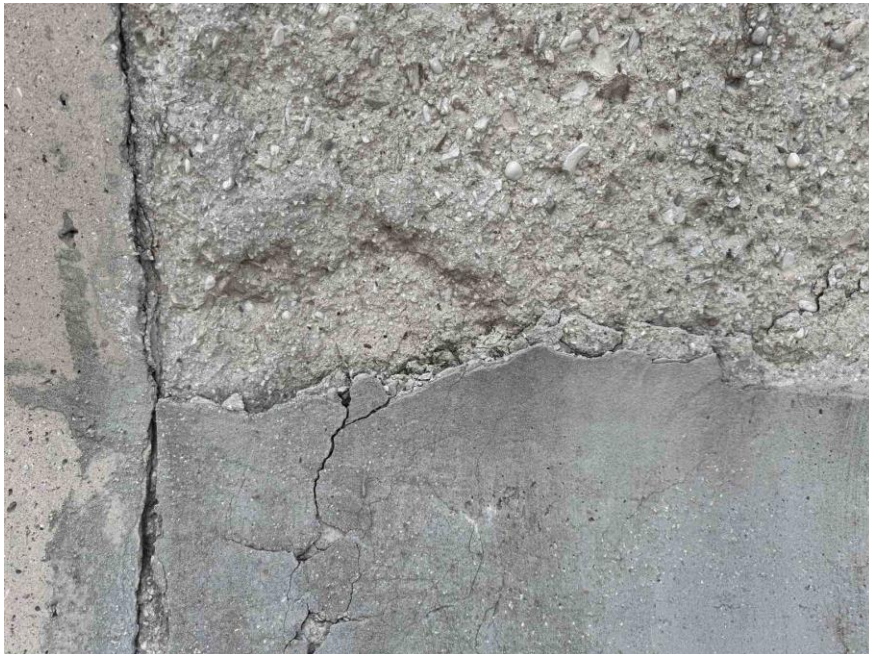
Figure 29 Vertical and transverse cracks along the lower section of the barrier, indicating structural fatigue and environmental wear

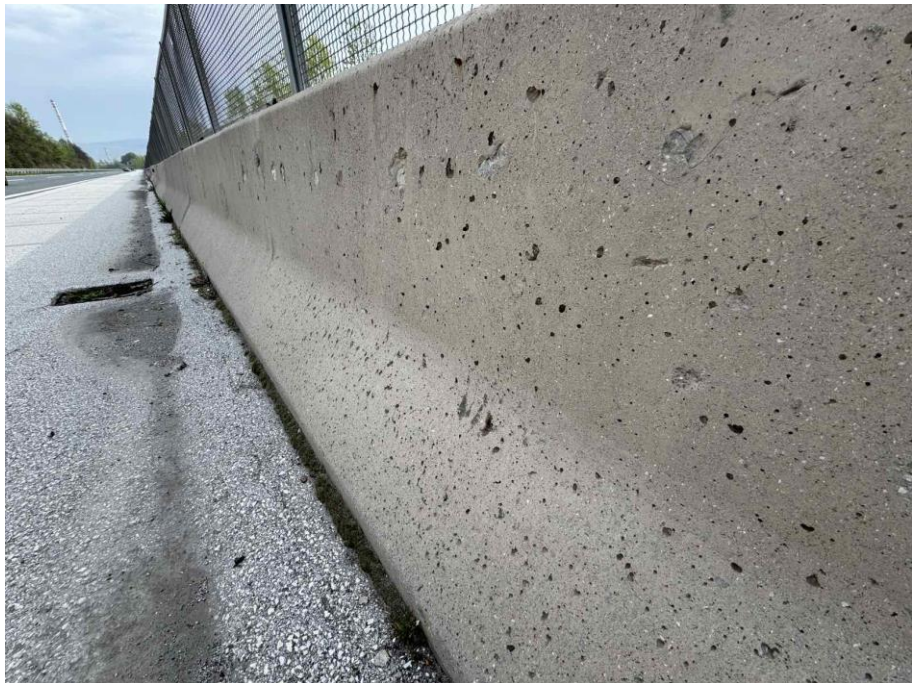
Photographic documentation further illustrated the variability in deterioration. In some instances, a barrier segment was nearly pristine and free from visible distress, while an adjacent segment displayed pronounced cracking, spalling, and discoloration. This stark contrast highlights the significant influence of micro-environmental factors such as slope and sun exposure on the rate and severity of barrier deterioration along the corridor.

Figure 30 Segment of a minimally deteriorated New Jersey barrier for comparison with damaged sections

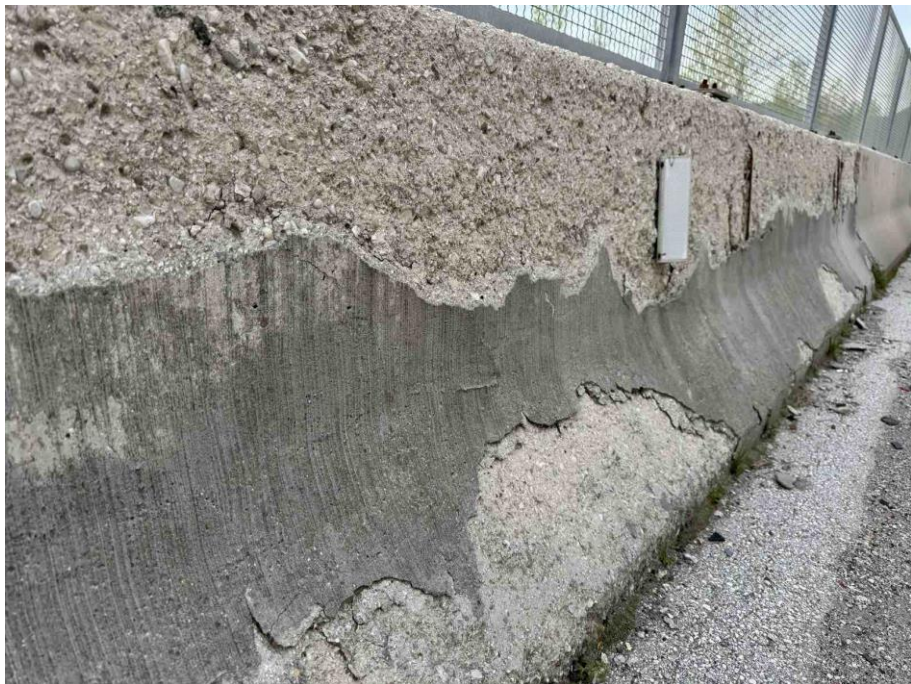
Figure 31 Widespread delamination and material separation likely due to inadequate surface treatment and poor curing

Finally, construction quality shouldn't be overlooked. Improved curing techniques, precise control of concrete mixes, and careful installation of joints help eliminate early-stage weaknesses. Attention to these details during construction can prevent significant long-term deterioration.
