## REHABILITATION SOLUTIONS FOR EXISTING STRUCTURES IN ROMANIA

Sorin Dan<sup>1</sup>

**Summary:** *The paper deals with aspects regarding strengthening of reinforced concrete existing structures in seismic zones, like Romania. Some case study and the rehabilitation of characteristic structures are analysed. The rehabilitation solutions were chosen in accordance with the actual stage of building deterioration as well as function of the actions characteristics. Classic (reinforced concrete and/or steel) and modern (Carbon Fibre Reinforced Polymers) materials and technologies for strengthening have been used.*

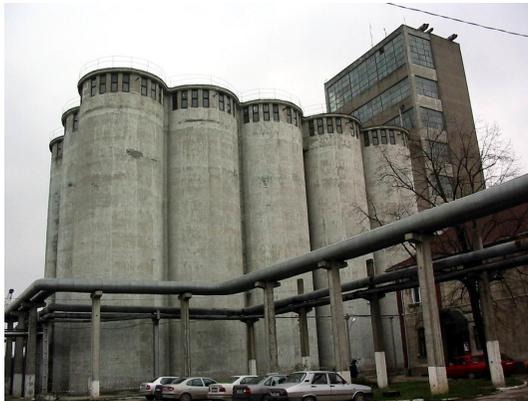
Figure 1. Reinforced concrete silos

The assessment and rehabilitation solutions for a group of silos owned by the SAB Miller Brewery Company “Timisoreana” are presented. The silos (*Figure 1*) were built 40 years ago and stand 28 m high and 7.30 m in diameter.

Initial silos inspection (1999) revealed large zones of circular cells with concrete cover dislocated and corrosion of circumferential steel reinforcement. Recent silos inspection and assessment (2004) emphasized other vulnerable parts: infrastructure and charging platform (gallery).

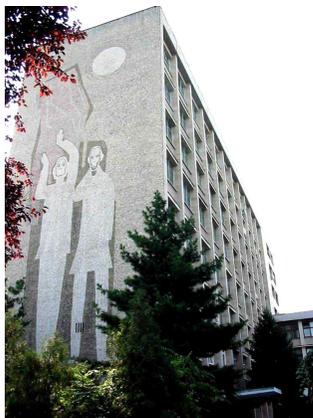
Figure 4. The Western University of Timisoara

The Western University of Timisoara has many buildings, among them the Main Building (*Figure 4 and 5*) that is used as administrative part as well as classrooms for students, was built in 1962-1963.

On examination of the building and from non-destructive measurements no important damages of the RC structure were noticed. Some local damage due to incipient reinforcement corrosion was detected at the columns of the ground storey.

Rehabilitation solution consists in strengthening of the columns located at the ground storey (*Figure 6 and 7*): some columns were strengthened in 1999 to prevent the local damages due to reinforcement corrosion; the other columns were rehabilitated in 2004

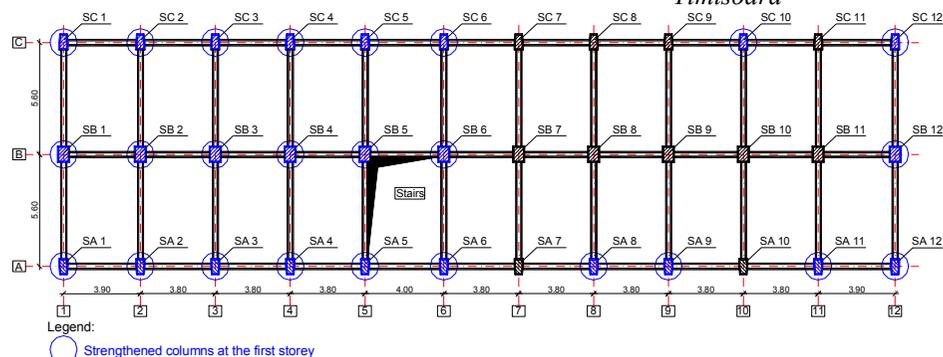
Figure 5. Framing plan – ground storey

- transversal and longitudinal frames with eight storeys and two spans of 5.6 m and eleven bays of 3.8 m;
- floors with girder mesh in two directions and a slab of 10 cm;
- foundation with a thick slab and deep beams in two directions.

- weakness of reinforcement and insufficient anchorage of beam-positive reinforcement at the beam-column joint, especially in the longitudinal direction;
- the drift limitation conditions are not within the admissible limits at the ground storey.

for decreasing the lateral displacements (drift limitation conditions) and for a homogeneous columns stiffness at the ground storey.

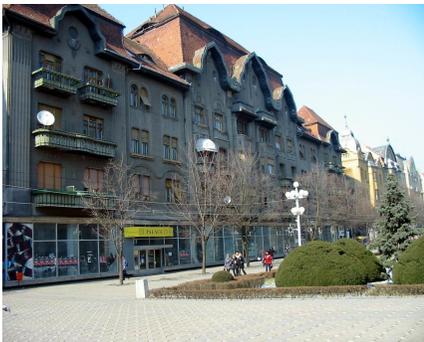
Figure 8. The "Palace" building

The "Palace" structure (Figure 8) is a huge building (underground floor, ground floor - restaurant, 3 storeys - apartments, timber roof), built before 1900's with a composite structure: masonry and reinforced concrete framed structure (Figure 9).

The building assessment emphasized some aspects: concrete quality is very variable in structural elements, having different classes (C8/10 - C16/20); some cracks in longitudinal beams; corrosion of the slab reinforcement; etc.

- strengthening of half from the existing columns (60x60cm coated by RC to become 90x90cm – *Figure 10*) and erecting of new transversal RC beams in order to create new transversal frames (*Figure 11*);
  - strengthening by RC coating of existing longitudinal beams;
  - rehabilitation of some structural elements having corroded reinforcement.
