ASSESSMENT OF THE SITUATION AND REMEDIATION MEASURES OF CHILDREN INSTITUTION " DOLORES " IN BELGRADE

Summary: This paper presents the assessment of damaged building built on sloping ground on the basis of the position and orientation of cracks recorded . It is believed that the damage to the building occurred as a result of landslides activation.

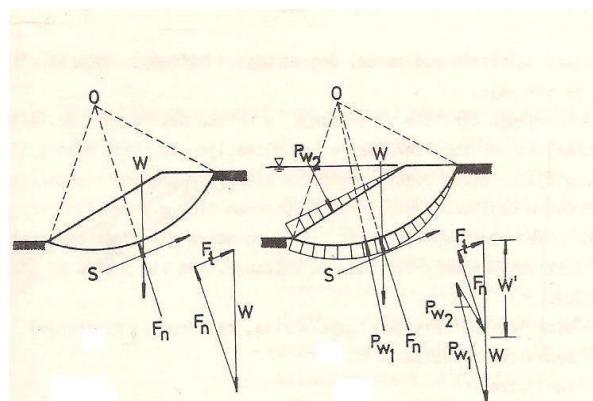
Figure 5. Impact on sliding body

In the simplest case , when the slope is not saturated with water and unencumbered by external forces , the forces acting on the sliding body (Figure 5) are the weight of the soil W, the normal component of the reaction to the sliding surface F_n , shear force F_t and S shear resistance along the sliding surface . These three forces are arranged in force polygon . If F_t is greater than S, the sliding will occur . In the case that the slope was fully submerged in the water and was long under these conditions , then, in addition to the force S, W, F_n , there will exist the hydrostatic pressure on the surface of the slope and the sliding surface . Their resultants are P_{w1} and P_{w2} . Forces polygon suggests that the combined action of P_{w1} and P_{w2} reduces W to W' is increasing (weight of soil soaked in water). Value of F_t is significantly lower than in the first case , but the S is lower also.
