## PROPAGATION OF VIBRATIONS AT THE ZEMUN SIDE OF THE ZEMUN-BORČA BRIDGE

**Summary:** *Experimental and numerical analysis of vibration propagation at the Zemun side of the Zemun-Borča bridge due to construction works is presented, as well as the slope stability analysis of the loess plateau, which is about 15-20m above the Danube level and with very steep, almost vertical slope.*

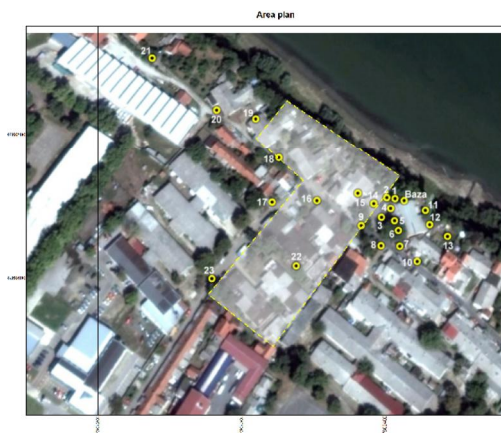
Fig. 1(a) Location of measurement points

prior to the beginning of the actual construction works, the general approach to vibration propagation analysis was to conduct the vibration transmission measurements due to controlled simulated construction works representing the worst case scenario, with respect to vibrations, of the future construction works. Also, prior to that, the ambient vibrations in the broader area of the site were made. Results of conducted sets of measurements are presented, among other forms, as the corresponding vibration distribution maps of ambient microtremor and of simulated construction works-induced vibrations. After that, assessment of vibration effects upon all buildings surrounding the site, and particularly upon the two most affected buildings at the edge of the loess plateau on both sides of the site, was made according to British and German standards BS 7385 (Part 2) and DIN 1450 (Part 3), as well as according to other available vibration assessment criteria. Vibration measurements were made by recording velocities and, for control purposes, accelerations. The basic measurements were done using the instrument TM-3C400, which is the seismometric 24-bit acquisition system with integrated GPS receiver. Three-axial velocimeters of the frequency range 0.1 - 600Hz were connected to the system. The system has an autonomous power supply of high capacity (48 hours of continuous work). Three-axial GeoSpace sensors were connected to the system, and measured data were stored in the computer memory. The sampling rate is 400 samples per second (400Hz), i.e. with the period, or the time interval of 2.5ms. During the acquisition of data the software package AcDat was used, while the later processing of data was done using the software packages GeoDas 2.11, Grapher 8 and Surfer 8. The control measurements were related to measurements of accelerations. As the main acquisition system the instrument MGCPlus by Hottinger Baldwin Messtechnik was used, which has 8-channel modul for acquisition of dynamic outputs from accelerometers with the differential voltage. The conversion is 20-bit, so the high precision of measurements is enabled. Vibrations were registered by the MEMS sensors by SILICODESIGNs, with the measurement range of  $\pm 2g$ , i.e.  $\pm 20m/s^2$ . The sensitivity of sensors is 2V/g, in the frequency range of 0 - 300Hz, which enables the precision of measurements of about  $0.001m/s^2$ . Figure 1 represents the layout of the measurement points and the instrument TM-3C400.

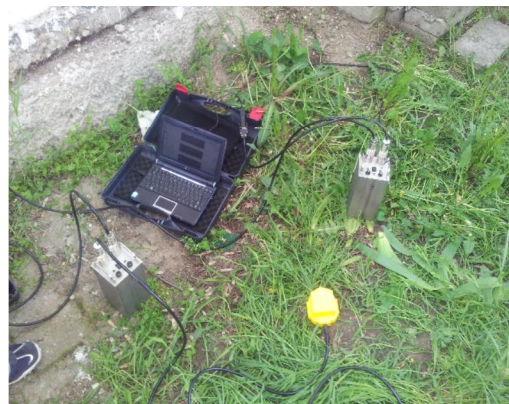
Fig. 1(b) Measurement instrument

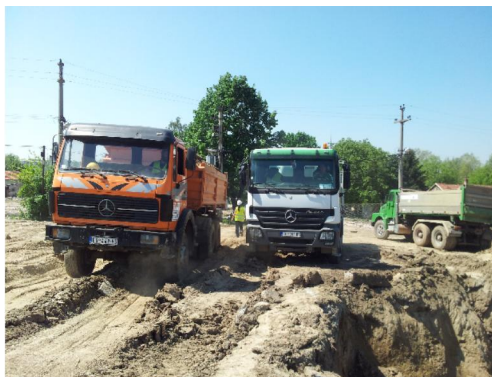
Fig. 2(a) Heavy truck and a mixer

In considered case of future construction works, the probable source of vibrations could be the movement of heavy trucks over uneven ground and resulting shock loads. Also, the works related to soil compaction during construction of the access road are to be expected. Having in mind the future dominant construction works with the most potential for generation of vibrations, for the simulation of construction works a concrete mixer, a heavy truck and a tracked excavator (bagger) were selected. Figure 2 represents the machines selected to represent the simulated construction work.

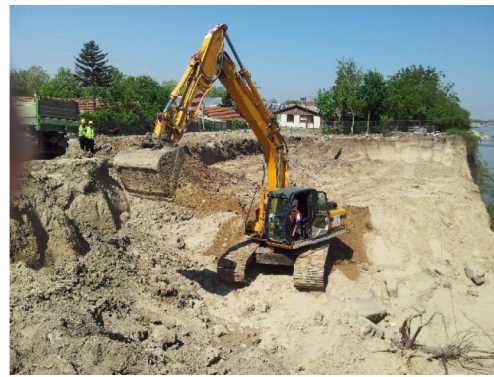
Fig. 2(b) Tracked excavator (bagger)

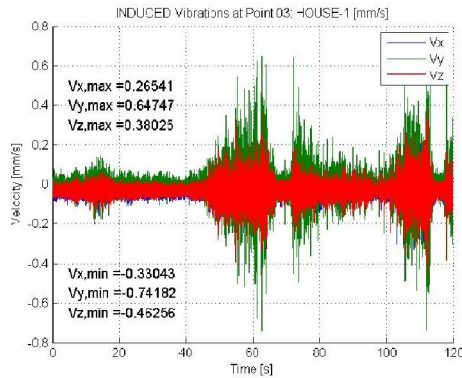
Fig. 4(a) Measured velocity time history near the House-1 (all 3 components)

dominant horizontal directions are defined using data presented in the Fig. 3(b). The time history of induced vibration velocities close to one of the houses at the edge of the loess plateau, called the House-1, is given in the Figure 4. Assessment of vibration effects upon building is mostly defined through the frequency dependant maximum velocities of the soil particles, the so-called PPV („Peak-Particle-Velocity”), which are measured at basement, i.e. at the soil near the wall on the side of vibration source:  $PPV=v(t)_{max}$ .

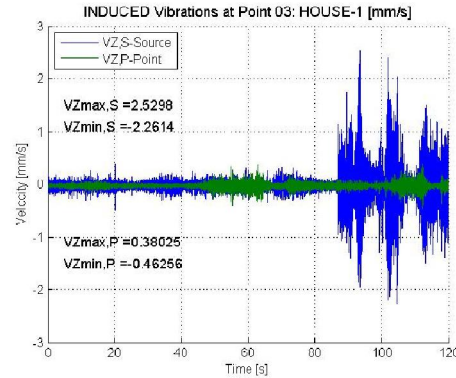
Fig. 4(b) Comparative time histories of vertical velocities  $V_z$  (source and House 1)

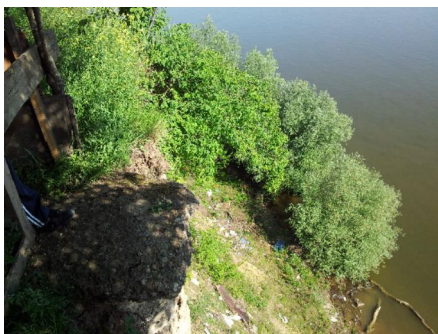
Fig. 5(a) View at the slope by the House 1      Fig. 5(b) Slope stability analysis (House 1)

GEOSTUDIO by the company GEO-SLOPE, Inc. Respecting the geotechnical soil properties, with some variations of the soil strength parameters, representing the geometric configuration of the slope, given underground water level etc., several numerical models of the slope were made. All ten different soil layers were presented in the numerical models, with the corresponding characteristics (soil thickness  $h$ , strength parameters  $\gamma$ ,  $\varphi$ ,  $c$ ). The level of the Danube was presented as the corresponding hydraulic pressure. At location of the House-1, the corresponding surface overpressure, representing the weight of the house, was given too. The slope stability analysis, i.e. determination of the slip surfaces and the factors of safety, was performed using the Morgenstern-Price method. View at the slope by the House-1 and results of the slope stability analysis are given in Fig. 5.

The conclusion was that the slope is conditionally stable, i.e. the factor of safety is about 1.0. However, one should keep in mind that the strength parameters of the soil are the result of soil investigation of only one, relatively far away, drillhole, so the obtained soil data are not sufficiently reliable. Having in mind the the soil data, above all the strenght parameters, are not sufficiently reliable, it may be concluded that the slope at location of the House-1 is conditionally stable. If into the soil under the house foundations, or in the immediate surrounding, some larger quantity of water appears, e.g. due to some damage of plumbing or sewage pipes, there is the great possibility of rapid violation of the slope stability at any moment. Consequently, the corresponding measures were prescribed.

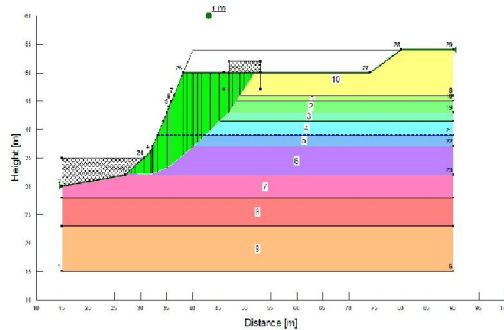
Fig. 6(a) The closest position of the rotary drilling rig (9.0m from the slope edge)

Besides the slope stability analysis of the profile just outside the construction site limits (location of the House-1), slope stability analysis was performed for the position of the bridge abuttment no.1 (longitudinal axis of the bridge). Due to slightly less steep profile towards the Danube, the factor of safety of 1.070 was obtained, which is slightly better then 1.030, but it is still low. After the removal of some 2.0m of the top layer soil, as presented in the Fig. 2(b), the factor of safety was obtained as FoS=1.199. Various phases of the work process related to construction of the abuttment no.1 were simulated (drilling of the piles, construction of the concrete block connecting the piles, the final indentation of the slope edge towards the Danube, protective coffer-dam in the Danube, etc.) and the correspondng factors of safety of the slope stability were determined. Based upon such analysis, the working range of heavy machines, especially the rotary drilling rig and the excavation bager, was defined and limited. For instance, prior to drilling of the 12 piles, the rotary drilling rig (or any heavy machine) was not allowed to come

closer than 9.0m from the edge of the slope. After construction of piles the slope is somewhat stabilized and the factor of safety is increased. Therefore, the limiting position of the excavator bager, which was used to form the final edge of the slope, was limited to 5.0m from the edge. Some phases of the slope stability analysis are given in the Fig. 6. Fig. 6(a) represents the closest position of the rotary drilling rig, while Fig. 6(b) represents the case when all 12 piles are constructed. The effect of piles for the slope stability is obvious: FoS is increased from 1.199 to 1.789 due to the presence of piles.

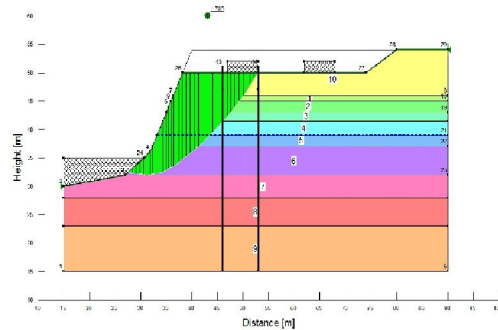
Fig. 6(b) Two heavy machines after construction of the piles
